Lone Star Stucco, LLC

Moisture Assessment Report

1234 Main St

Houston, TX 77007

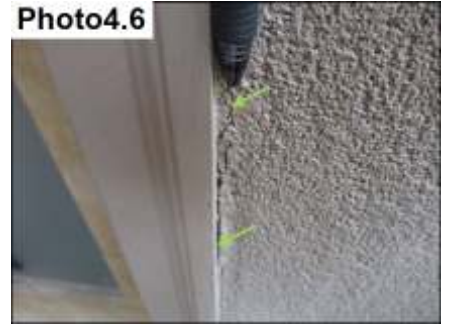
Photo4.6

Door Trim And Miter Sealants/ Seal

Grid Location	Item Description	Moisture Readings	Substrate Condition	Observations
Green Arrows	Door Trim And Miter Sealants			The door trim and miter sealants are separated or missing. The inspector suggests to have a qualified stucco waterproofing contractor seal this area with NP1 or low modulus sealant an effort to prevent moisture intrusion. These types of sealants are of high quality and compatible with stucco and other termination points. Please refer to photos #4.2, #4.3, #4.4, #4.5 and #4.6 for more detail.

- The door trim and miter sealants are separated or missing. The inspector suggests to have a qualified stucco waterproofing contractor seal this area with NP1 or low modulus sealant an effort to prevent moisture intrusion. These types of sealants are of high quality and compatible with stucco and other termination points. Please refer to photos #4.2, #4.3, #4.4, #4.5 and #4.6 for more detail.

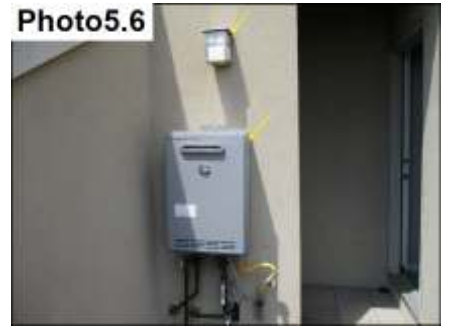
Photo5.6

Penetration Sealants/ Seal

Grid Location	Item Description	Moisture Readings	Substrate Condition	Observations
Yellow Arrows	Penetration Sealants			The penetration sealants are separated or missing. The inspector suggests to have a qualified stucco waterproofing contractor seal this area with NP1 or low modulus sealant an effort to prevent moisture intrusion. These types of sealants are of high quality and compatible with stucco and other termination points. Please refer to photos #5.2, #5.3, #5.4, #5.5 and #5.6 for more detail.

- The penetration sealants are separated or missing. The inspector suggests to have a qualified stucco waterproofing contractor seal this area with NP1 or low modulus sealant an effort to prevent moisture intrusion. These types of sealants are of high quality and compatible with stucco and other termination points. Please refer to photos #5.2, #5.3, #5.4, #5.5 and #5.6 for more detail.

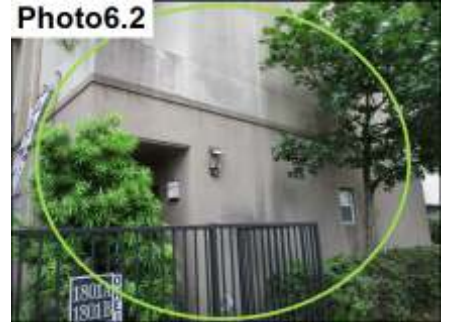
Photo6.2

Mildew And Run-Off Stains/ Seal

Grid Location	Item Description	Moisture Readings	Substrate Condition	Observations
Green Circle	Mildew And Run-Off Stains			Mildew and run-off stains were noted in this location. The inspector suggests to clean the area as needed. Please refer to photos #6.2, #6.3, #6.4, #6.5 and #6.6 for more detail.

- Mildew and run-off stains were noted in this location. The inspector suggests to clean the area as needed. Please refer to photos #6.2, #6.3, #6.4, #6.5 and #6.6 for more detail.

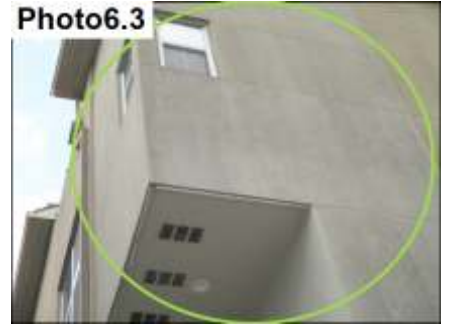
Photo6.3

Mildew And Run-Off Stains/ Seal

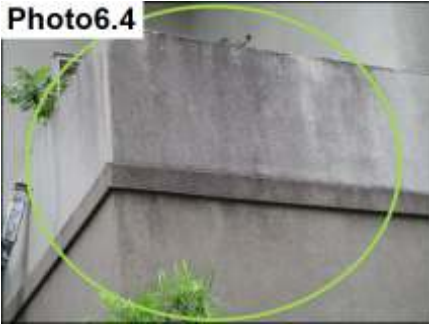
Photo6.4

Mildew And Run-Off Stains/ Seal

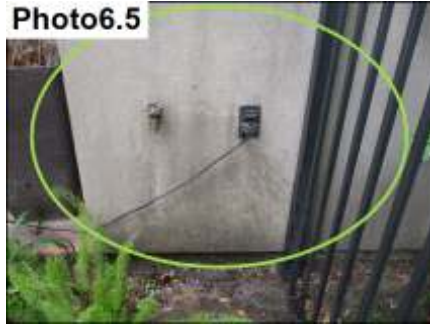
Photo6.5

Mildew And Run-Off Stains/ Seal

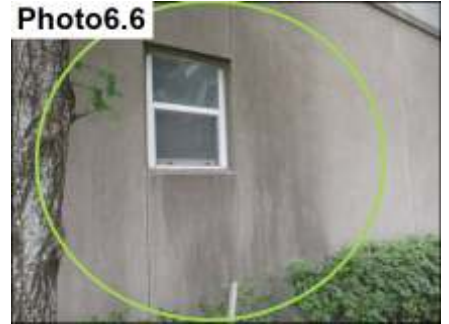
Photo6.6

Mildew And Run-Off Stains/ Seal

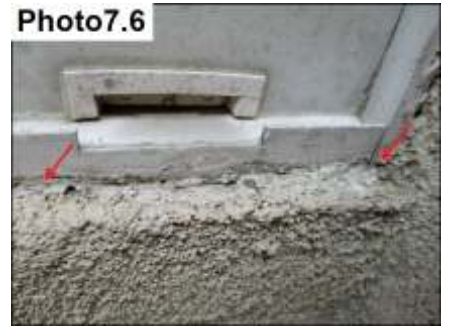
Photo7.6

Window Sealants/ Seal

Grid Location	Item Description	Moisture Readings	Substrate Condition	Observations
Red Arrows	Window Sealants			The window sealants are separated. The inspector suggests to have a qualified stucco waterproofing contractor seal this area with NP1 or low modulus sealant an effort to prevent moisture intrusion. These types of sealants are of high quality and compatible with stucco and other termination points. Please refer to photos #7.2, #7.3, #7.4, #7.5 and #7.6 for more detail.

- The window sealants are separated. The inspector suggests to have a qualified stucco waterproofing contractor seal this area with NP1 or low modulus sealant an effort to prevent moisture intrusion. These types of sealants are of high quality and compatible with stucco and other termination points. Please refer to photos #7.2, #7.3, #7.4, #7.5 and #7.6 for more detail.

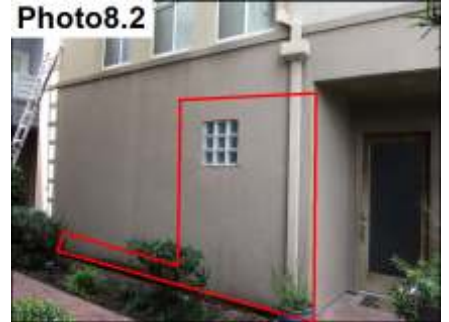
Photo8.2

Confirmed Substrate And Frame Damage/ Repair

Grid Location	Item Description	Moisture Readings	Substrate Condition	Observations
Red Box	Confirmed Substrate And Frame Damage			Confirmed substrate and frame damage was noted in the first floor wall below the leaking glass block window and second floor bank of windows. Additionally substrate damage is noted from the black plastic at the base of wall to the left. The inspector suggests to have a qualified stucco waterproofing contractor further assess and repair this area in an effort to prevent moisture intrusion. Please refer to photos #8.2, #8.3, #8.4, #8.5 and #8.6 for more detail.

- Confirmed substrate and frame damage was noted in the first floor wall below the leaking glass block window and second floor bank of windows. Additionally substrate damage is noted from the black plastic at the base of wall to the left. The inspector suggests to have a qualified stucco waterproofing contractor further assess and repair this area in an effort to prevent moisture intrusion. Please refer to photos #8.2, #8.3, #8.4, #8.5 and #8.6 for more detail.

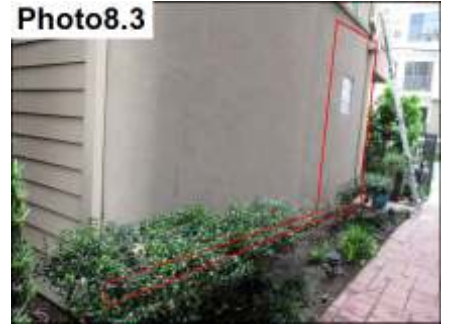
Photo8.3

Confirmed Substrate And Frame Damage/ Repair

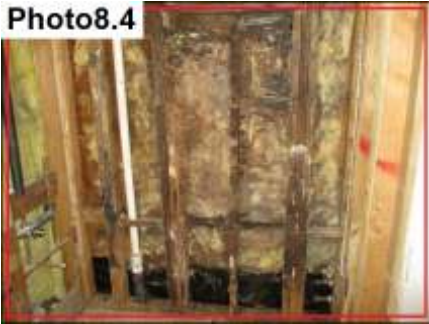
Photo8.4

Confirmed Substrate And Frame Damage/ Repair

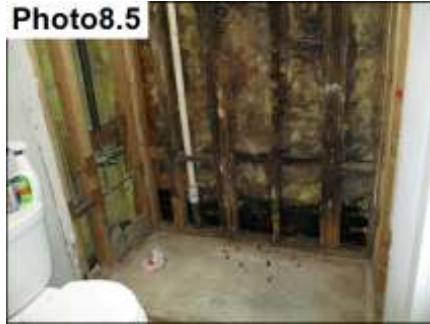
Photo8.5

Confirmed Substrate And Frame Damage/ Repair

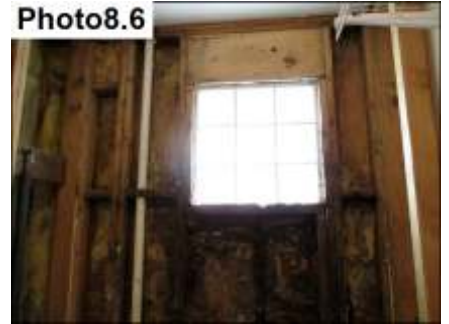
Photo8.6

Confirmed Substrate And Frame Damage/ Repair

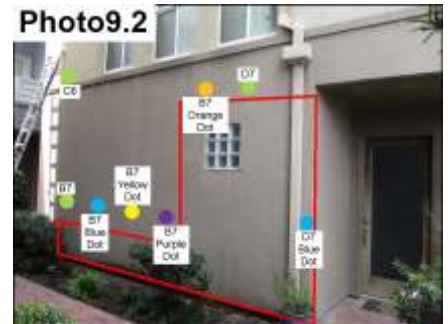
Photo9.2

Grid Location	Item Description	Moisture Readings	Substrate Condition	Observations
Red Box	Confirmed Substrate And Frame Damage			Please refer to page 8 for detail.
B7	Wall Left Of Damage	14%	Firm	A moisture probe was made at the wall left of the damage. The substrate was firm with no damage noted at this time. Please refer to photo #9.1 for more detail.
C6	Wall Left Above Damage	15%	Firm	A moisture probe was made at the wall left above the damage. The substrate was firm with no damage noted at this time. Please refer to photo #9.1 for more detail.
B7 - Blue Dot	Wall Left Of Damage	17%	Firm	A moisture probe was made at the wall left of the damage. The substrate was firm with no damage noted at this time. Please refer to photo #9.1 for more detail.
B7 - Yellow Dot	Wall Left Of Damage	16%	Firm	A moisture probe was made at the wall left of the damage. The substrate was firm with no damage noted at this time. Please refer to photo #9.1 for more detail.

B7 - Purple Dot	Wall Left Of Damage	17%	Firm	A moisture probe was made at the wall left of the damage. The substrate was firm with no damage noted at this time. Please refer to photo #9.1 for more detail.
B7 - Orange Dot	Above Damage	17%	Firm	A moisture probe was made above the damage. The substrate was firm with no damage noted at this time. Please refer to photo #9.1 for more detail.
D7	Above Damage	14%	Firm	A moisture probe was made above the damage. The substrate was firm with no damage noted at this time. Please refer to photo #9.1 for more detail.
D7 - Blue Dot	Wall Right	16%	Firm	A moisture probe was made at the wall right. The substrate was firm with no damage noted at this time. Please refer to photo #9.1 for more detail.

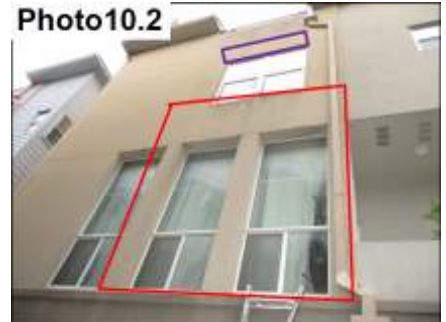
Photo10.2

Confirmed Substrate And Potential Frame Damage/ Repair/Add Relief

Grid Location	Item Description	Moisture Readings	Substrate Condition	Observations
Purple Box	Potential Substrate Damage / Core Sample			Potential damage is noted in the third floor window header below the failing rooftop pony wall with cracked flat accent. The inspector suggests to have a qualified stucco waterproofing contractor core sample assess then repair this area if needed. Note The inspector was unable to reach this location. Please refer to photos #10.1 for more detail.
Red Box	Confirmed Substrate And Potential Frame Damage			Confirmed substrate and potential frame damage is noted in the second floor window header below the failing rooftop pony wall with cracked flat accent. The inspector suggests to have a qualified stucco waterproofing contractor further assess the extent of damage then repair this area as needed and to install a relief in an effort to allow proper moisture evacuation. Please refer to photos #10.2, #10.3, #10.4, #10.5 and #10.6 for more detail.

- Confirmed substrate and potential frame damage is noted in the second floor window header below the failing rooftop pony wall with cracked flat accent. The inspector suggests to have a qualified stucco waterproofing contractor further assess the extent of damage then repair this area as needed and to install a relief in an effort to allow proper moisture evacuation. Please refer to photos #10.2, #10.3, #10.4, #10.5 and #10.6 for more detail.

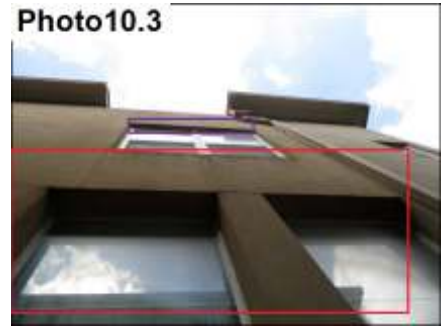
Photo10.3

Confirmed Substrate And Potential Frame Damage/ Repair/Add Relief

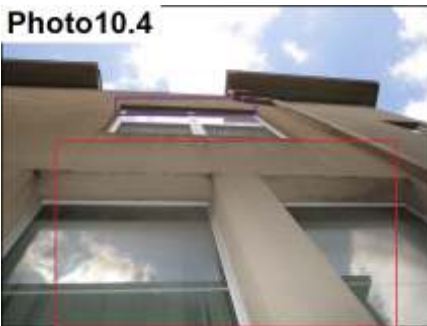
Photo10.4

Confirmed Substrate And Potential Frame Damage/ Repair/Add Relief

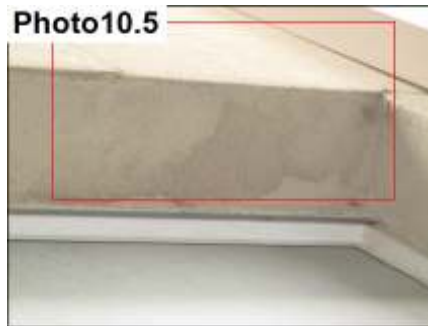
Photo10.5

Confirmed Substrate And Potential Frame Damage/ Repair/Add Relief

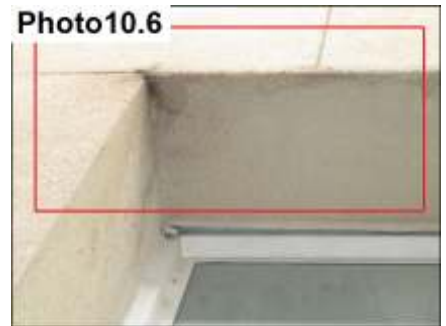
Photo10.6

Confirmed Substrate And Potential Frame Damage/ Repair/Add Relief

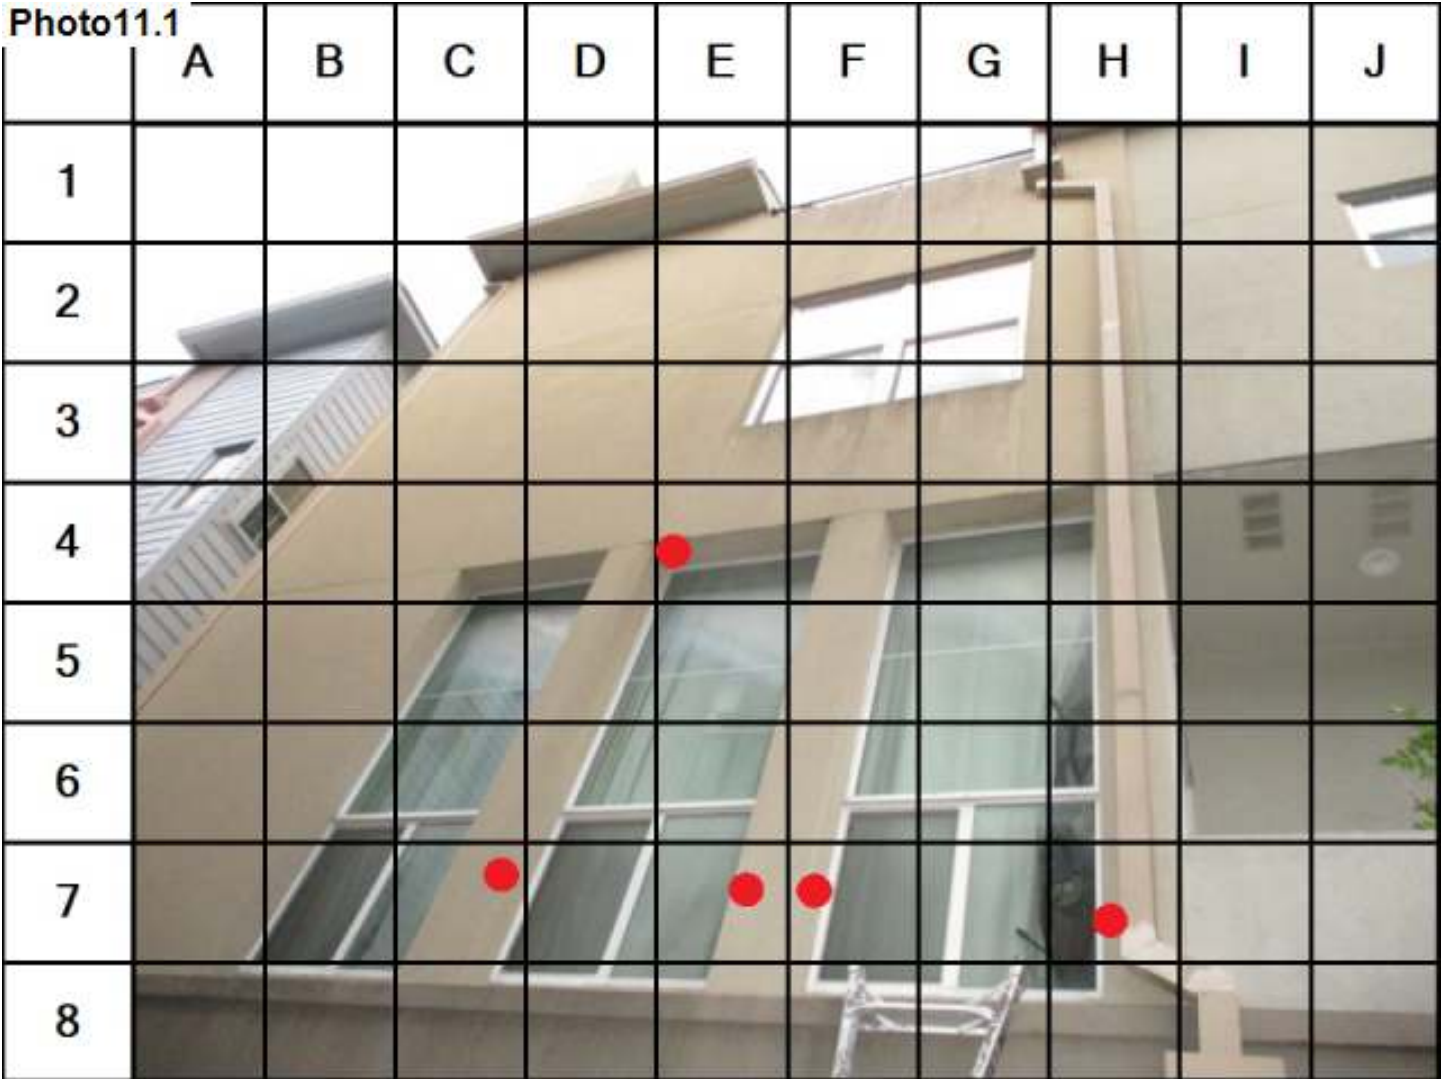
Photo11.1

Grid Location	Item Description	Moisture Readings	Substrate Condition	Observations
C7	Between Windows	21%	Semi-Firm	A moisture probe was made between the windows. An elevated moisture reading was noted with a semi-firm substrate.
E7	Between Windows	27%	Semi-Soft	A moisture probe was made between the windows. An elevated moisture reading was noted with a semi-soft substrate. The inspector suggests to modify this area as needed.
F7	Between Windows	25%	Semi-Soft	A moisture probe was made between the windows. An elevated moisture reading was noted with a semi-soft substrate. The inspector suggests to modify this area as needed.
H7	Between Windows	22%	Semi-Firm	A moisture probe was made between the windows. An elevated moisture reading was noted with a semi-firm substrate.
E4	Bottom Wall		None	A moisture probe was made at the bottom wall. No substrate was noted in this location. The inspector suggests to modify this area as needed.

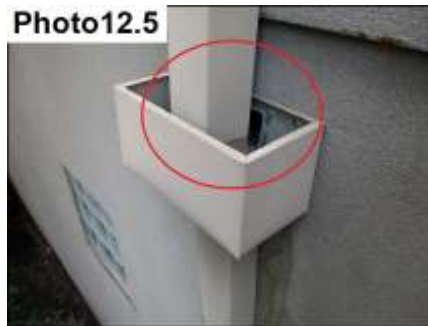
Photo12.5

Scupper Sealants Missing / Seal

Grid Location	Item Description	Moisture Readings	Substrate Condition	Observations
Pink Line	Flat Accent			A flat accent has been noted at these areas. The inspector suggests to consult with a qualified stucco waterproofing contractor to add a metal cap to all flat accents in an effort to prevent moisture intrusion. Please refer to photos #12.2, #12.3 and #12.4 for more detail.
Red Circle	Scupper Sealants			The scupper sealants are missing. The inspector suggests to have a qualified stucco waterproofing contractor seal this area with NP1 or low modulus sealant an effort to prevent moisture intrusion. These types of sealants are of high quality and compatible with stucco and other termination points. Please refer to photos #12.5 and #12.6 for more detail.

- The scupper sealants are missing. The inspector suggests to have a qualified stucco waterproofing contractor seal this area with NP1 or low modulus sealant an effort to prevent moisture intrusion. These types of sealants are of high quality and compatible with stucco and other termination points. Please refer to photos #12.5 and #12.6 for more detail.

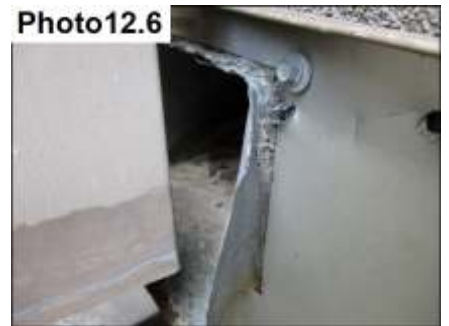
Photo12.6

Scupper Sealants Missing / Seal

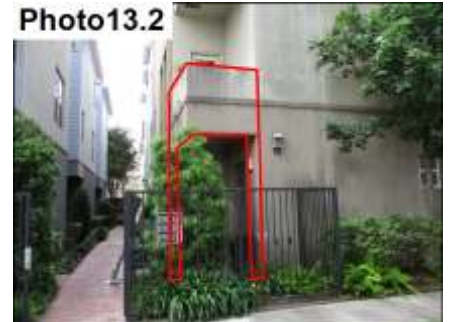
Photo13.2

Confirmed Substrate And Potential Frame Damage/ Repair

Grid Location	Item Description	Moisture Readings	Substrate Condition	Observations
Red Box	Confirmed Substrate And Potential Frame Damage			Confirmed substrate and potential frame damage is noted in the balcony and corner walls below. Note that the soffit in this location is hard board. The inspector suggests to have a qualified stucco waterproofing contractor repair this area in an effort to prevent moisture intrusion. Please refer to photos #13.2, #13.3, #13.4, #13.5 and #13.6 for more detail.
D7	Corner Wall Below Failing Balcony		None	A moisture probe was made at the corner wall below the failing balcony. No substrate was noted in this location. The inspector suggests to modify this area as needed.
E7	Corner Wall Below Failing Balcony		None	A moisture probe was made at the corner wall below the failing balcony. No substrate was noted in this location. The inspector suggests to modify this area as needed.

D6	Below Failing Balcony		None	A moisture probe was made below the failing balcony. No substrate was noted in this location. The inspector suggests to modify this area as needed.
E6	Below Failing Balcony		None	A moisture probe was made below the failing balcony. No substrate was noted in this location. The inspector suggests to modify this area as needed.

- Confirmed substrate and potential frame damage is noted in the balcony and corner wall below. Note that the soffit in this location is hard board. The inspector suggests to have a qualified stucco waterproofing contractor repair this area in an effort to prevent moisture intrusion. Please refer to photos #13.2, #13.3, #13.4, #13.5, #13.6, #14.1, #14.2 and #14.3 for more detail.

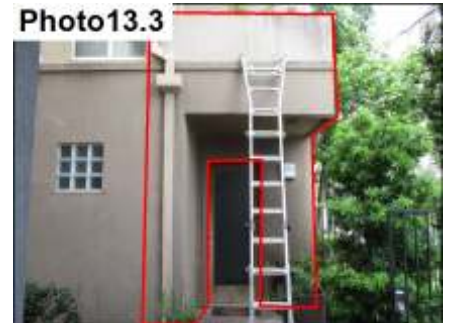
Photo13.3

Confirmed Substrate And Potential Frame Damage/ Repair

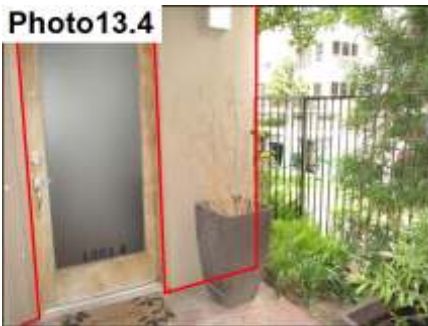
Photo13.4

Confirmed Substrate And Potential Frame Damage/ Repair

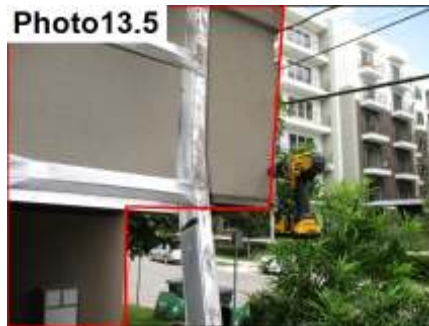
Photo13.5

Confirmed Substrate And Potential Frame Damage/ Repair

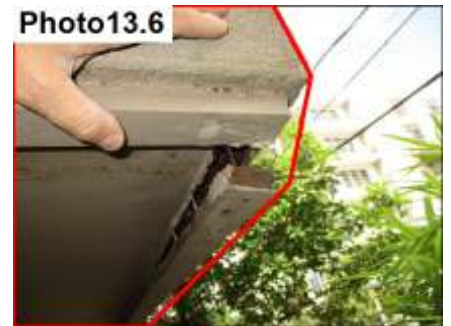
Photo13.6

Confirmed Substrate And Potential Frame Damage/ Repair

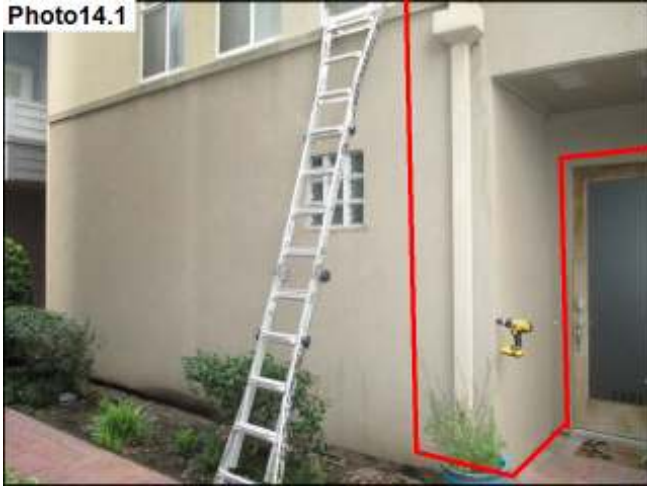
Photo14.1

Confirmed Substrate And Potential Frame Damage/
Repair

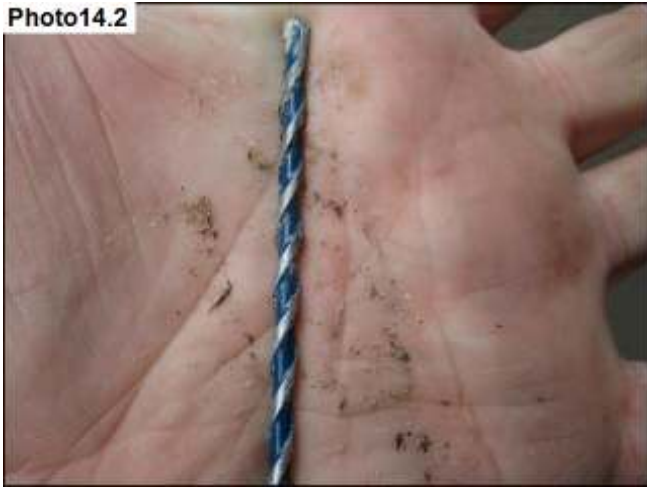
Photo14.2

Confirmed Substrate And Potential Frame Damage/
Repair

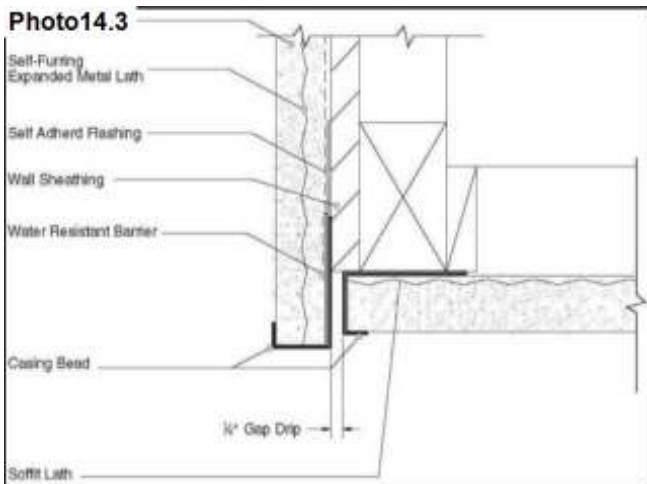
Photo14.3

Proper Relief Detail

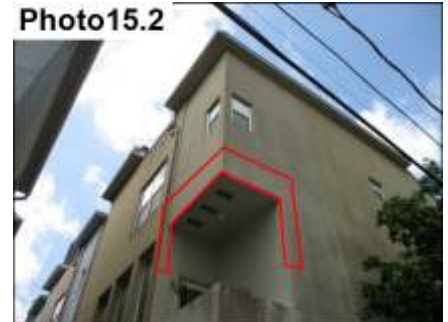
Photo15.2

Substrate Damage/ Repair

Grid Location	Item Description	Moisture Readings	Substrate Condition	Observations
Red Box	Substrate Damage			Confirmed substrate and potential frame damage is noted at the bottom wall below windows and the corner walls below. Note that the soffit in this location is hard board. The inspector suggests to have a qualified stucco waterproofing contractor repair this area in an effort to prevent moisture intrusion Please refer to photos #15.2, #15.3 and #15.4 for more detail.
D5	Wall Below Bumpout Wall At Corner		None	A moisture probe was made at the wall below the bumpout wall at the corner. No substrate was noted in this location. The inspector suggests to modify this area as needed.
E5	Wall Below Bumpout Wall At Corner	27%	Semi-Soft	A moisture probe was made at the wall below the bumpout wall at the corner. An elevated moisture reading was noted with a semi-soft substrate. The inspector suggests to modify this area as needed.

E4	Bottom Wall		None	A moisture probe was made at the bottom wall. No substrate was noted in this location. The inspector suggests to modify this area as needed.

- Confirmed substrate and potential frame damage is noted at the bottom wall below windows and the corner walls below. Note that the soffit in this location is hard board. The inspector suggests to have a qualified stucco waterproofing contractor repair this area in an effort to prevent moisture intrusion. Please refer to photos #15.2, #15.3 and #15.4 for more detail.

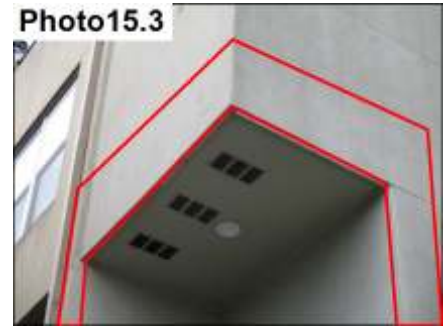
Photo15.3

Substrate Damage/ Repair

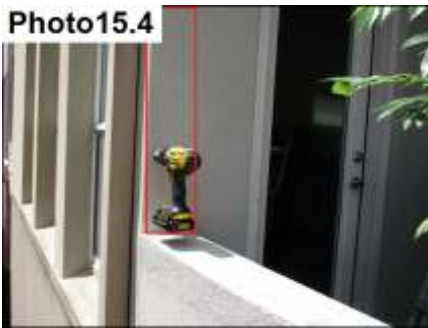
Photo15.4

Substrate Damage/ Repair

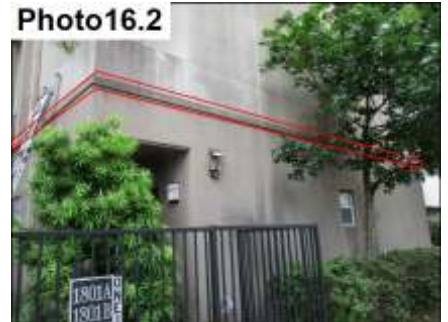
Photo16.2

Broken Accent Band/ Repair And Seal

Grid Location	Item Description	Moisture Readings	Substrate Condition	Observations
Red Box	Broken Accent Band			The accent band in this location is broken. The inspector suggests to have a qualified stucco waterproofing contractor repair and seal this area with NP1 or low modulus sealant an effort to prevent moisture intrusion. These types of sealants are of high quality and compatible with stucco and other termination points. Please refer to photos #16.2, #16.3, #16.4, #16.5 and #16.6 for more detail.

- The accent band in this location is broken. The inspector suggests to have a qualified stucco waterproofing contractor repair and seal this area with NP1 or low modulus sealant an effort to prevent moisture intrusion. These types of sealants are of high quality and compatible with stucco and other termination points. Please refer to photos #16.2, #16.3, #16.4, #16.5 and #16.6 for more detail.

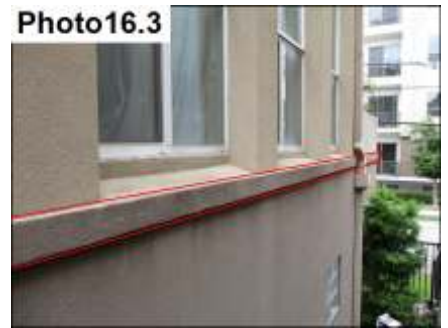
Photo16.3

Broken Accent Band/ Repair And Seal

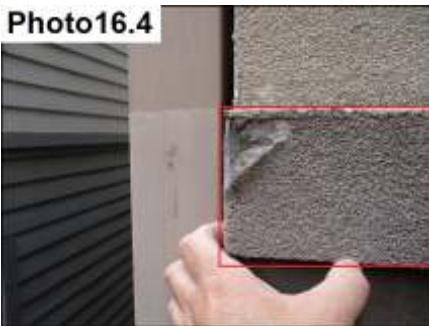
Photo16.4

Broken Accent Band/ Repair And Seal

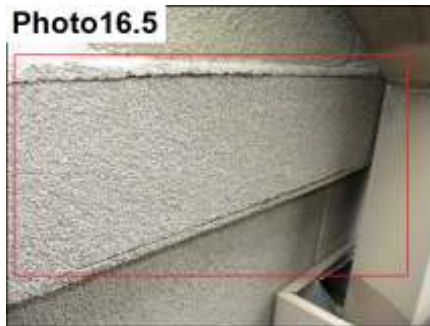
Photo16.5

Broken Accent Band/ Repair And Seal

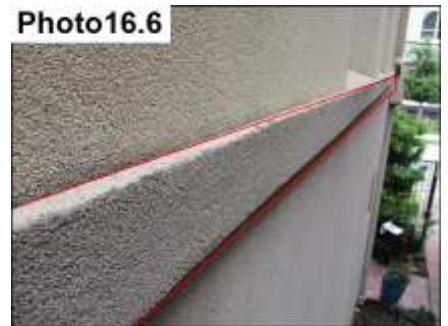
Photo16.6

Broken Accent Band/ Repair And Seal

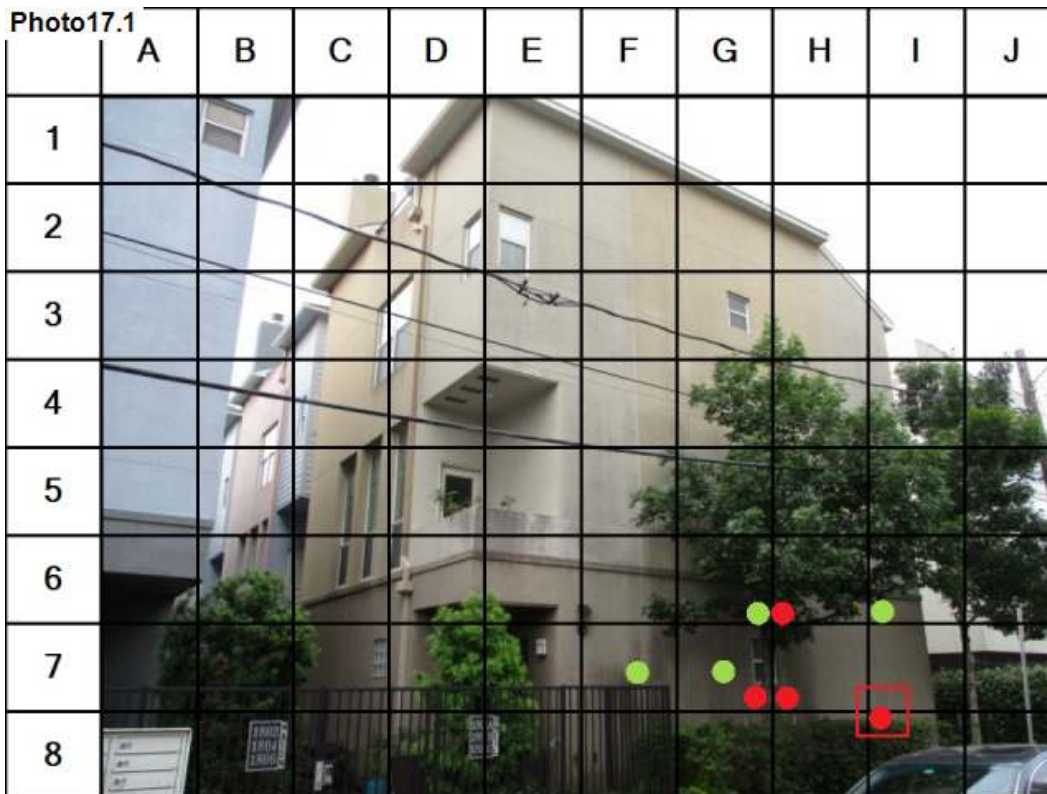
Grid Location	Item Description	Moisture Readings	Substrate Condition	Observations
Red Box	Core Sample			Semi-Firm substrate was noted At grid I8 below the direct vent above. The inspector suggests to have a qualified stucco waterproofing contractor core sample assess then repair this area if needed. Please refer to photos #17.1 for more detail.
F7	Right Wall	18%	Firm	A moisture probe was made at the right wall. The substrate was firm with no damage noted at this time.
G7	Right Wall	18%	Firm	A moisture probe was made at the right wall. The substrate was firm with no damage noted at this time.
H7	Right Wall Below Window Bottom Right	24%	Semi-Firm	A moisture probe was made at the right wall below the window bottom right. An elevated moisture reading was noted with a semi-firm substrate.
G7/ Red Dot	Right Wall Below Window Bottom Left	25%	Semi-Firm	A moisture probe was made at the right wall below the window bottom left. An elevated moisture reading was noted with a semi-firm substrate.

H6	Right Wall At Window Header Right	20%	Firm	A moisture probe was made at the right wall at the window header right. An elevated moisture reading was noted with a firm substrate.
G6	Right Wall At Window Header Left	18%	Firm	A moisture probe was made at the right wall at the window header left. The substrate was firm with no damage noted at this time.
I8	Right Wall	24%	Semi-Firm	A moisture probe was made at the right wall. An elevated moisture reading was noted with a semi-firm substrate.
I6	Above Probe I8	18%	Firm	A moisture probe was made above probe I8. The substrate was firm with no damage noted at this time.

- Semi-Firm substrate was noted At grid I8 below the direct vent above. The inspector suggests to have a qualified stucco waterproofing contractor core sample assess then repair this area if needed. Please refer to photos #17.1 for more detail.

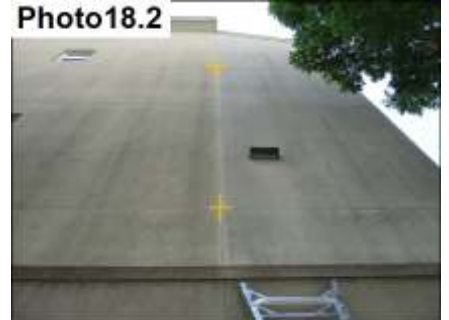
Photo18.2

Control Joint Cracks/ Seal And Paint

Grid Location	Item Description	Moisture Readings	Substrate Condition	Observations
Red Box	Minor Substrate Black Plastic			Minor substrate damage and black plastic noted in this area. Black plastic is when the substrate has been sealed, which creates a reservoir to hold moisture. The inspector suggests to consult with a qualified stucco water proofing contractor to cut the black plastic and further investigate and repair any substrate damage. Please refer to 18.1 for more detail.
Orange Lines	Control Joint Cracks			Control joint cracks are noted in this location. The inspector suggests to have a qualified stucco waterproofing contractor seal and paint these cracks in an effort to prevent moisture intrusion. Please refer to photos #18.2, #18.3, #18.4, #18.5 and #18.6 for more detail.

- Control joint cracks are noted in this location. The inspector suggests to have a qualified stucco waterproofing contractor seal and paint these cracks in an effort to prevent moisture intrusion. Please refer to photos #18.2, #18.3, #18.4, #18.5 and #18.6 for more detail.

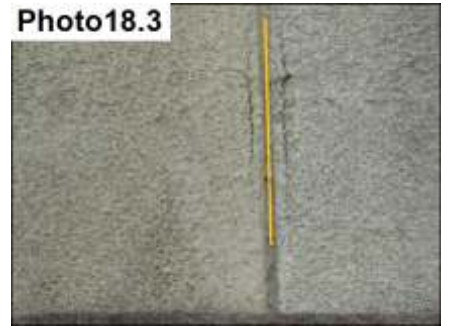
Photo18.3

Control Joint Cracks/ Seal And Paint

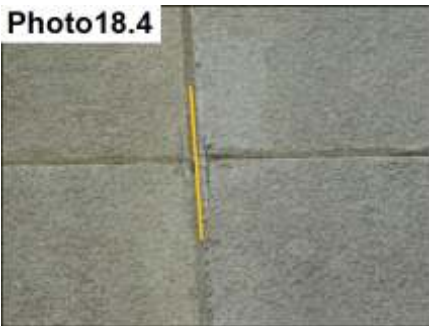
Photo18.4

Control Joint Cracks/ Seal And Paint

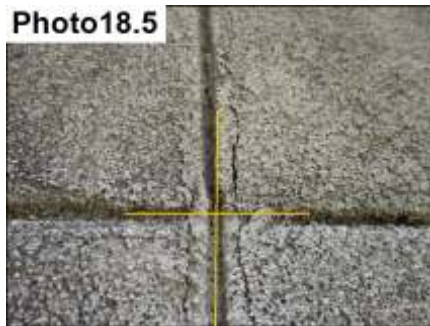
Photo18.5

Control Joint Cracks/ Seal And Paint

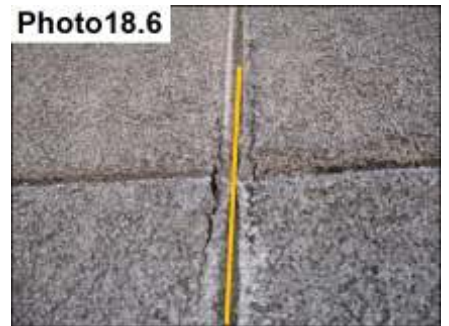
Photo18.6

Control Joint Cracks/ Seal And Paint

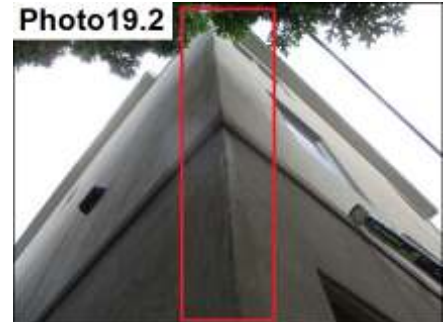
Photo19.2

Confirmed Substrate And Potential Frame Damage/ Repair

Grid Location	Item Description	Moisture Readings	Substrate Condition	Observations
Orange Box	Potential Damage Noted			Potential substrate and frame damage is noted in this corner wall. The inspector suggests to have a qualified stucco waterproofing contractor further assess and repair this area as needed in an effort to prevent moisture intrusion. Please refer to photos #19.1 for more detail.
Red Box	Confirmed Substrate And Potential Frame Damage			Confirmed substrate and potential frame damage is noted in this corner wall. The inspector suggests to have a qualified stucco waterproofing contractor repair this area in an effort to prevent moisture intrusion. Please refer to photos #19.2, #19.3, #19.4, #19.5 and #19.6 for more detail.
F7	Corner Wall At Sizeable Crack		None	A moisture probe was made at the corner wall at the sizeable crack. No substrate was noted in this location. The inspector suggests to modify this area as needed.

F5	Corner Wall At Sizeable Crack		None	A moisture probe was made at the corner wall at the sizeable crack. No substrate was noted in this location. The inspector suggests to modify this area as needed.

- Confirmed substrate and potential frame damage is noted in this corner wall. The inspector suggests to have a qualified stucco waterproofing contractor repair this area in an effort to prevent moisture intrusion. Please refer to photos #19.2, #19.3, #19.4, #19.5 and #19.6 for more detail.

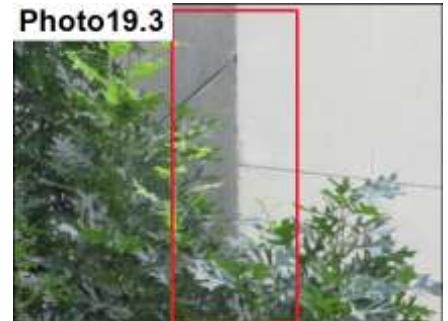
Photo19.3

Confirmed Substrate And Potential Frame Damage/ Repair

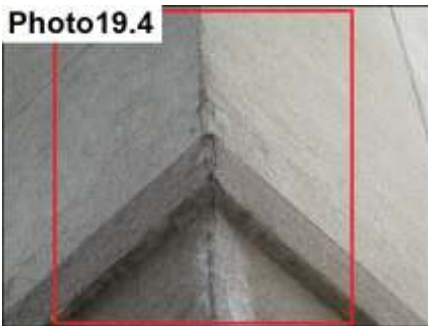
Photo19.4

Confirmed Substrate And Potential Frame Damage/ Repair

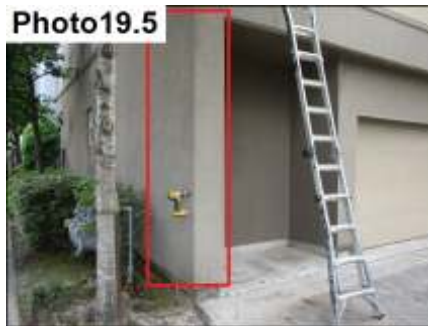
Photo19.5

Confirmed Substrate And Potential Frame Damage/ Repair

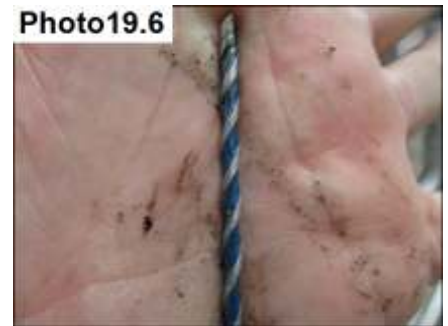
Photo19.6

Confirmed Substrate And Potential Frame Damage/ Repair

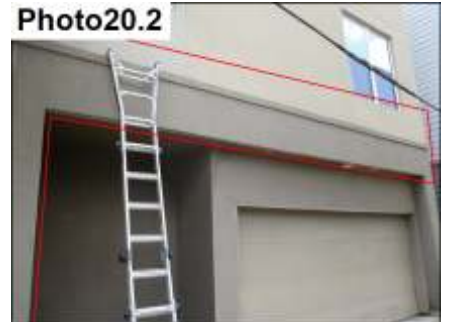
Photo20.2

Damage/ Repair

Grid Location	Item Description	Moisture Readings	Substrate Condition	Observations
Red Box	Damage			Confirmed substrate and potential frame damage is noted at the bottom wall below windows the windows. Note that the soffit in this location is hard board. The inspector suggests to have a qualified stucco waterproofing contractor repair this area in an effort to prevent moisture intrusion. Please refer to photos #20.2, #20.3, #20.4, #20.5 and #20.6 for more detail.
I7	Garage Header	18%	Firm	A moisture probe was made at the garage header. The substrate was firm with no damage noted at this time.
G6	Bottom Wall		None	A moisture probe was made at the bottom wall. No substrate was noted in this location. The inspector suggests to modify this area as needed.
H6	Bottom Wall		None	A moisture probe was made at the bottom wall. No substrate was noted in this location. The inspector suggests to modify this area as needed.

I6	Bottom Wall		None	A moisture probe was made at the bottom wall. No substrate was noted in this location. The inspector suggests to modify this area as needed.

- Damage was noted in the bottom wall. The inspector suggests to have a qualified stucco waterproofing contractor repair this area in an effort to prevent moisture intrusion. Please refer to photos #20.2, #20.3, #20.4, #20.5 and #20.6 for more detail.

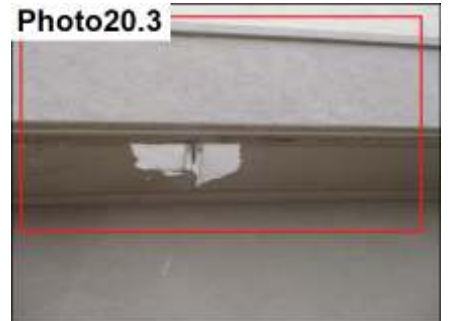
Photo20.3

Damage/ Repair

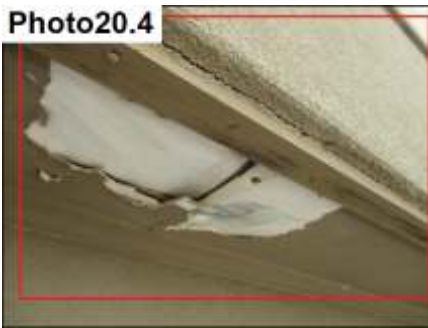
Photo20.4

Damage/ Repair

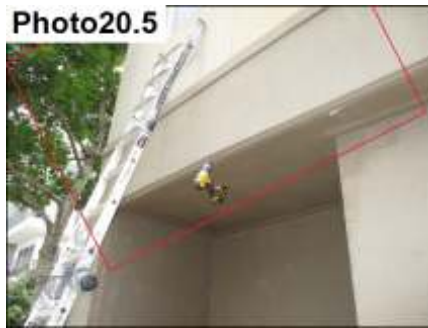
Photo20.5

Damage/ Repair

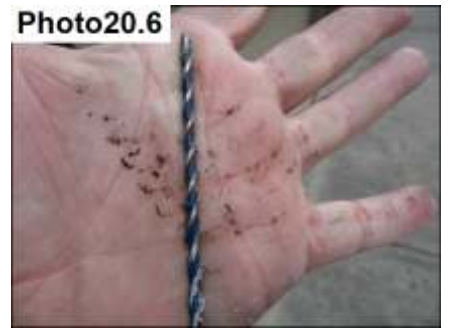
Photo20.6

Damage/ Repair

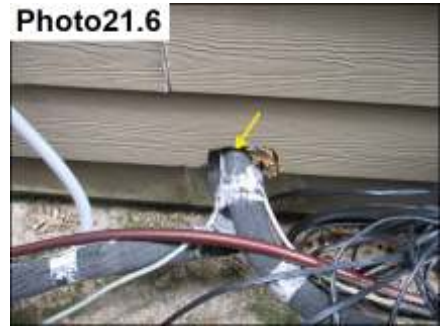
Photo21.6

Penetration Sealants/ Seal

Grid Location	Item Description	Moisture Readings	Substrate Condition	Observations
Yellow Arrows	Penetration Sealants			The penetration sealants are missing. The inspector suggests to have a qualified waterproofing contractor seal this area as needed in an effort to prevent moisture intrusion. Please refer to photos #21.2, #21.3, #21.4, #21.5 and #21.6 for more detail.

- The penetration sealants are missing. The inspector suggests to have a qualified waterproofing contractor seal this area as needed in an effort to prevent moisture intrusion. Please refer to photos #21.2, #21.3, #21.4, #21.5 and #21.6 for more detail.

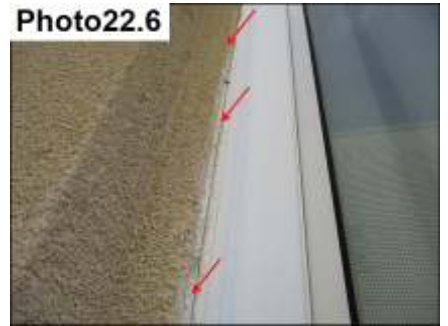
Photo22.6

Window Sealants/ Seal

Grid Location	Item Description	Moisture Readings	Substrate Condition	Observations
Red Arrows	Window Sealants			The window sealants are separated. The inspector suggests to have a qualified waterproofing contractor seal this area as needed in an effort to prevent moisture intrusion. Please refer to photos #22.2, #22.3, #22.4 and #22.6 for more detail.

- The window sealants are separated. The inspector suggests to have a qualified waterproofing contractor seal this area as needed in an effort to prevent moisture intrusion. Please refer to photos #22.2, #22.3, #22.4 and #22.6 for more detail.

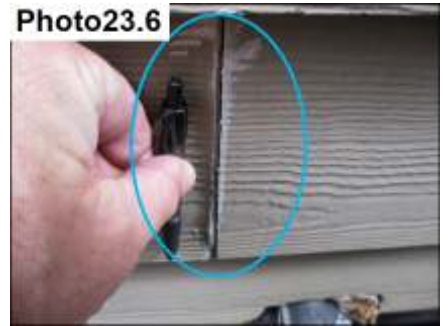
Photo23.6

Siding Sealants/ Seal

Grid Location	Item Description	Moisture Readings	Substrate Condition	Observations
Blue Circle	Siding Sealants			The siding sealants are separated. The inspector suggests to have a qualified waterproofing contractor seal this area as needed in an effort to prevent moisture intrusion. Please refer to photos #23.2, #23.3, #23.4, #23.5 and #23.6 for more detail.

- The siding sealants are separated. The inspector suggests to have a qualified waterproofing contractor seal this area as needed in an effort to prevent moisture intrusion. Please refer to photos #23.2, #23.3, #23.4, #23.5 and #23.6 for more detail.

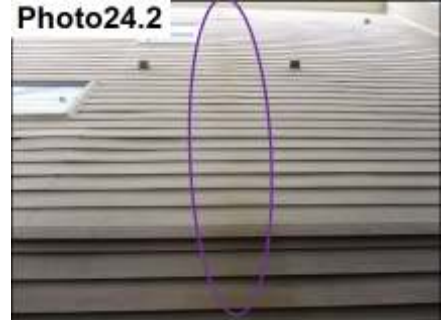
Photo24.2

Rust Stains/ Clean And Paint

Grid Location	Item Description	Moisture Readings	Substrate Condition	Observations
Purple Circle	Rust Stains			Rust stains from the over-flow are noted in this area. The inspector suggests to clean this location with a wire brush and paint as needed. Please refer to photos #24.2, #24.3 and #24.4 for more detail.

- Rust stains from the over-flow are noted in this area. The inspector suggests to clean this location with a wire brush and paint as needed. Please refer to photos #24.2, #24.3 and #24.4 for more detail.

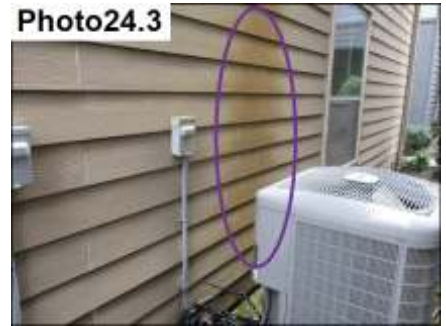
Photo24.3

Rust Stains/ Clean And Paint

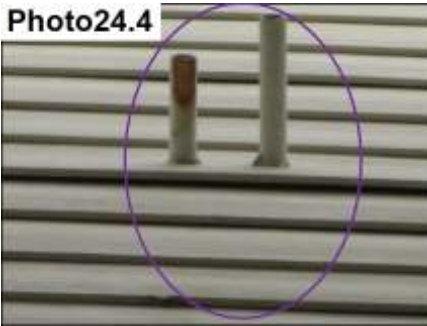
Photo24.4

Rust Stains/ Clean And Paint

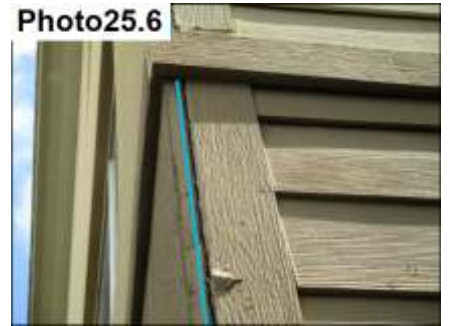
Photo25.6

Siding Trim/Stucco Termination Sealants/ Seal

Grid Location	Item Description	Moisture Readings	Substrate Condition	Observations
Blue Lines	Siding Trim/Stucco Termination Sealants			The siding trim/stucco termination sealants are separated. The inspector suggests to have a qualified stucco waterproofing contractor seal this area with NP1 or low modulus sealant an effort to prevent moisture intrusion. These types of sealants are of high quality and compatible with stucco and other termination points. Please refer to photos #25.2, #25.3, #25.4, #25.5 and #25.6 for more detail.

- The siding trim/stucco termination sealants are separated. The inspector suggests to have a qualified stucco waterproofing contractor seal this area with NP1 or low modulus sealant an effort to prevent moisture intrusion. These types of sealants are of high quality and compatible with stucco and other termination points. Please refer to photos #25.2, #25.3, #25.4, #25.5 and #25.6 for more detail.

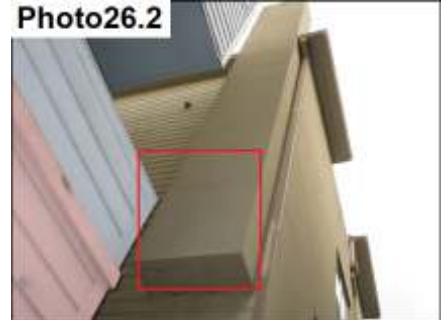
Photo26.2

Confirmed Substrate And Potential Frame Damage

Grid Location	Item Description	Moisture Readings	Substrate Condition	Observations
Orange Box	Potential Damage / Core Sample			Potential substrate frame damage is noted in the chimney chase. The inspector suggests to have a qualified stucco waterproofing contractor further assess and repair this area as needed and to install a relief in an effort to allow proper moisture evacuation. Please refer to photos #26.1 for more detail.
Red Box	Confirmed Substrate And Potential Frame Damage			Confirmed substrate and potential frame damage is noted in the chimney chase. The inspector suggests to have a qualified stucco waterproofing contractor repair this area as needed and to install a relief in an effort to allow proper moisture evacuation. Please refer to photos #26.2, #26.3, #26.4, #26.5 and #26.6 for more detail.

- Confirmed substrate and potential frame damage is noted in the chimney chase. The inspector suggests to have a qualified stucco waterproofing contractor repair this area as needed and to install a relief in an effort to allow proper moisture evacuation. Please refer to photos #26.2, #26.3, #26.4, #26.5 and #26.6 for more detail.

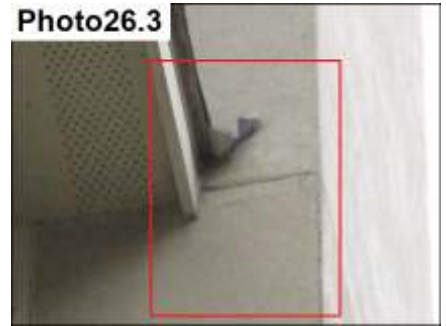
Photo26.3

Confirmed Substrate And Potential Frame Damage

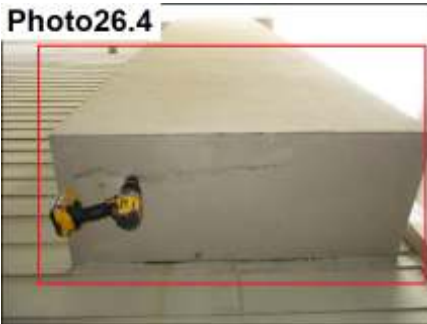
Photo26.4

Confirmed Substrate And Potential Frame Damage

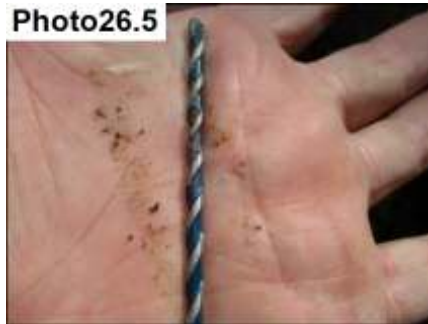
Photo26.5

Confirmed Substrate And Potential Frame Damage

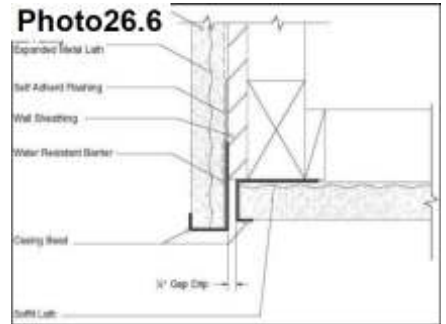
Photo26.6

Proper Detail
