Lone Star Stucco, LLC

Moisture Assessment Report

12345 Sample St

2/24/2019

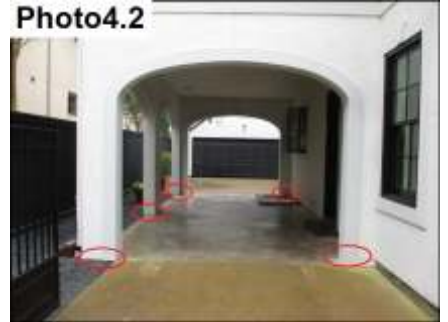
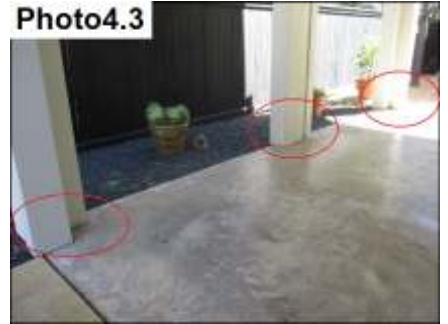
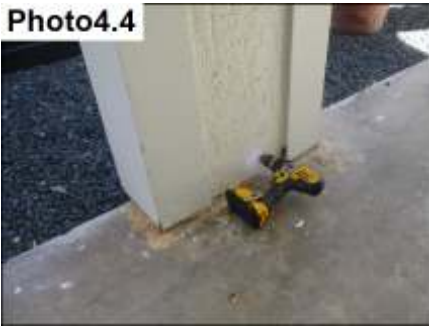
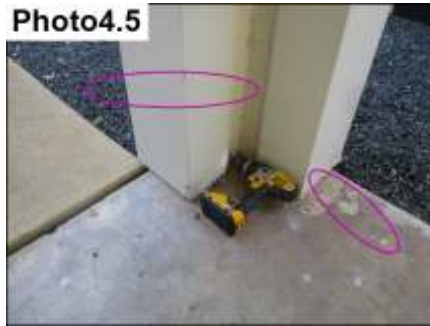
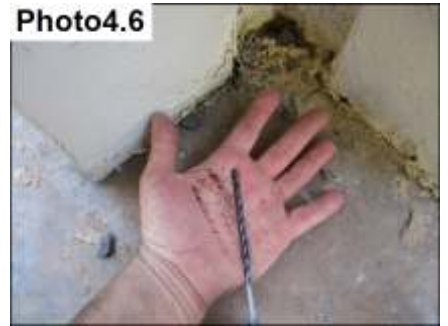
- The three columns and two pilaster terminations are damaged. The inspector suggest to have a qualified stucco repair contractor further asses and repair as needed in an effort to prevent moisture intrusion. Please refer to photos #4.2, #4.3, #4.4, #4.5 and #4.6 for more detail.

Substrate Damage /Repair

Grid Location	Item Description	Moisture Readings	Substrate Condition	Observations
Purple Arrows	Stucco In Contact With Grade			The three columns and two pilaster terminations are damaged. The inspector suggest to have a qualified stucco repair contractor further asses and repair as needed in an effort to prevent moisture intrusion. Please refer to photos #4.2, #4.3, #4.4, #4.5 and #4.6 for more detail.

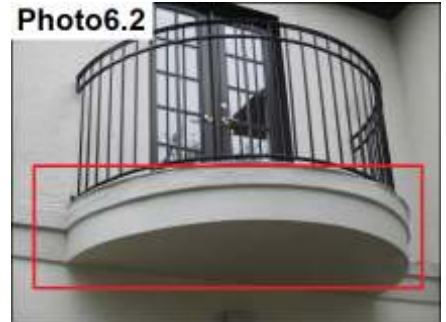
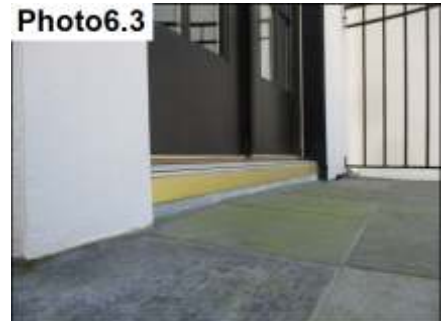
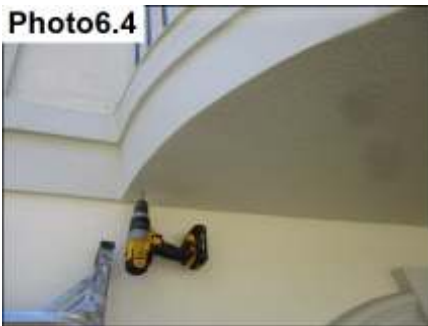
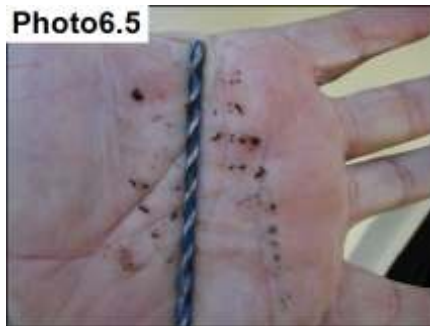
- The balcony flashing is failing and substrate damage noted The inspector suggests to have a qualified stucco waterproofing contractor to repair this area and install a relief in an effort to prevent moisture intrusion. Please refer to photos #6.2, #6.3, #6.4, #6.5 and #6.6 for more detail.

Failing Balcony Flashing/ Modify

Grid Location	Item Description	Moisture Readings	Substrate Condition	Observations
Red Box	Failing Balcony			The balcony flashing is failing and substrate damage noted The inspector suggests to have a qualified stucco waterproofing contractor to repair this area and install a relief in an effort to prevent moisture intrusion. Please refer to photos #6.2, #6.3, #6.4, #6.5 and #6.6 for more detail.
F5	Bottom Balcony		None	A moisture probe was made at the bottom balcony. No substrate was noted at this time, suggested to modify area as needed.

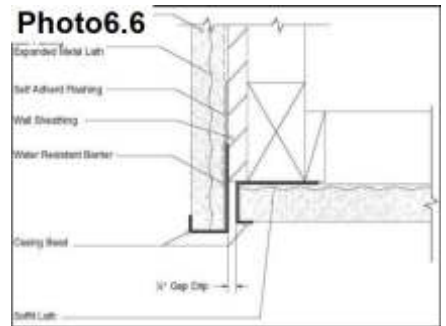
Photo6.6

Proper Relief Detail

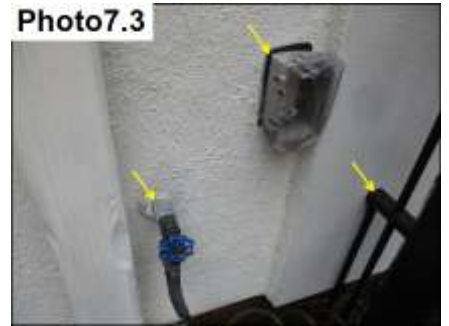
Photo7.3

- The penetration sealants are missing. The inspector suggests to have a qualified stucco waterproofing contractor seal this area with NP1 or low modulus sealant in an effort to prevent moisture intrusion. These types of sealants are of high quality and compatible with stucco and other termination points. Please refer to photos #7.3, #22.2, #22.3 and #22.4 for more detail.

Penetration Sealants/ Seal

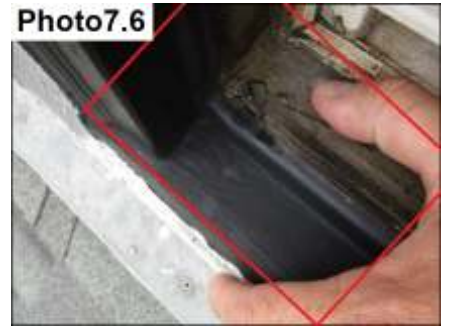
Photo7.6

- Wood rot is noted in the window frame. The inspector suggests to have a qualified waterproofing contractor repair in an effort to prevent moisture intrusion. Please refer to photo #7.6 for more detail.

Wood Rot/ Repair

Red Box	Wood Rot			Wood rot is noted in the window frame. The inspector suggests to have a qualified waterproofing contractor repair in an effort to prevent moisture intrusion. Please refer to photo #7.6 for more detail.

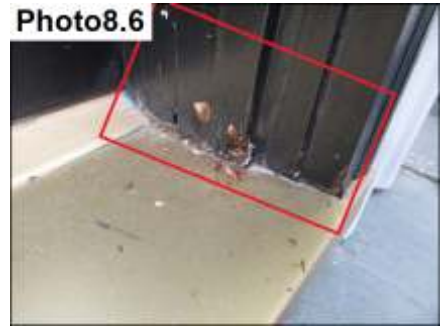
Photo8.6

- Wood rot is noted in the bottom right door trim. The inspector suggests to have a qualified waterproofing contractor repair in an effort to prevent moisture intrusion. Please refer to photo #8.6 for more detail.

Wood Rot/ Repair

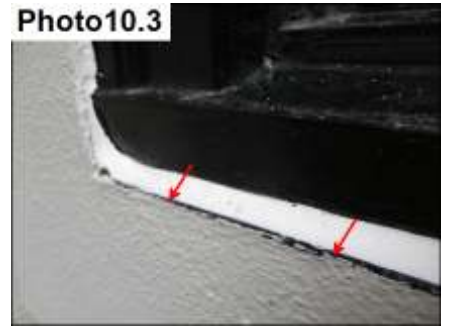
Photo10.3

- The window sealants are separated. The inspector suggests to have a qualified stucco waterproofing contractor seal this area with NP1 or low modulus sealant in an effort to prevent moisture intrusion. These types of sealants are of high quality and compatible with stucco and other termination points. Please refer to photos #10.2, #10.3, #14.2, #14.3, #14.4, #14.5, #16.2, #16.3, #16.4 and #16.5 for more detail.

Window Sealants/ Seal

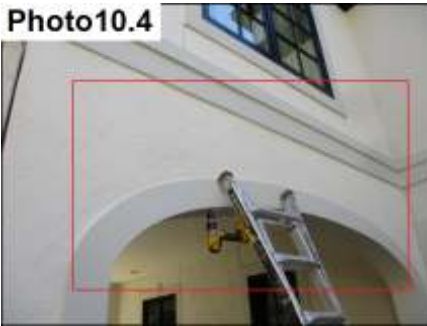
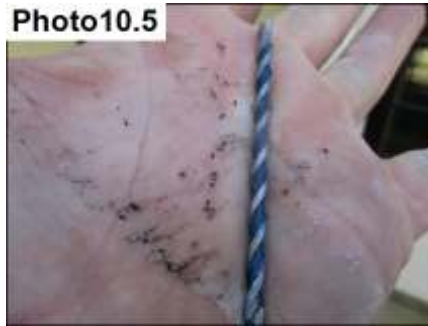
- The bottom of arch below the windows has substrate damage. The inspector suggests to have a qualified stucco waterproofing contractor to repair this area and install a relief in an effort to prevent moisture intrusion. Please refer to photos #10.4, and #10.5 for more detail.

Substrate Damage/ Repair

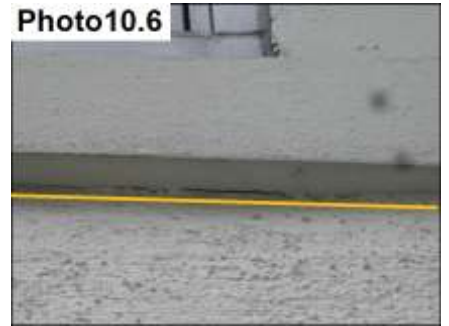
Photo10.6

- The accent/stucco termination sealants are separated. The inspector suggests to have a qualified stucco waterproofing contractor seal this area with NP1 or low modulus sealant in an effort to prevent moisture intrusion. These types of sealants are of high quality and compatible with stucco and other termination points. Please refer to photo #10.6 for more detail.

Accent/Stucco Termination Sealants/ Seal

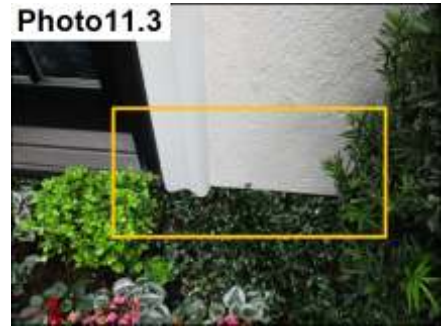
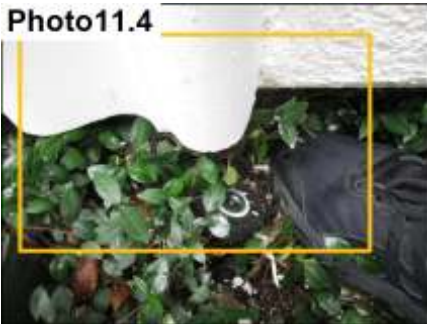
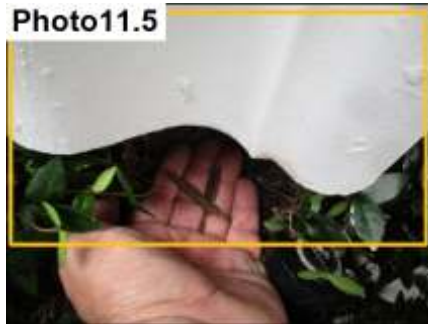
- The improper direction of the sprinkler in this area as caused minor substrate damage to the bottom right of the door threshold. The inspector suggests to have a qualified waterproofing contractor repair this area in an effort to prevent moisture intrusion. Please refer to photos #11.3, #11.4 and #11.5 for more detail.

Minor Substrate Damage/ Assess
And Repair

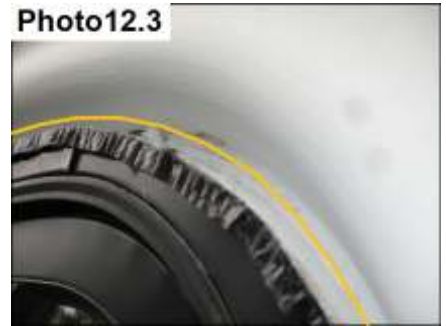
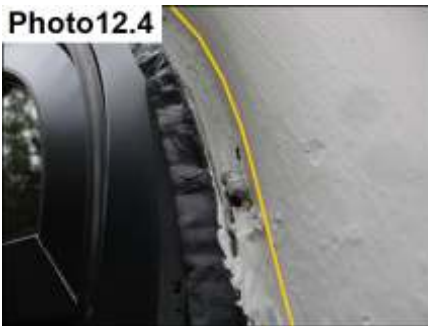
- The window/accent sealants are missing or deteriorating. The inspector suggests to have a qualified stucco waterproofing contractor seal this area with NP1 or low modulus sealant in an effort to prevent moisture intrusion. These types of sealants are of high quality and compatible with stucco and other termination points. Please refer to photos #12.2, #12.3 and #12.4 for more detail.

Window/Accent Sealants/ Seal

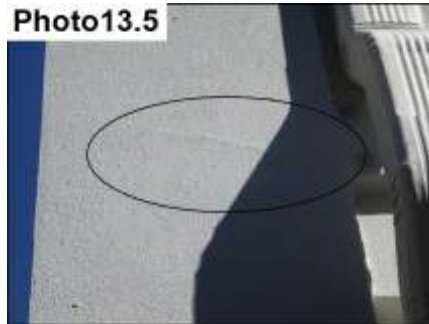
Photo13.5

Previously Sealed Minor Crack/ Positive Detail

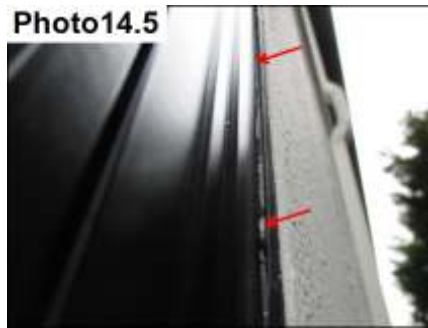
Photo14.5

Window Sealants/ Seal

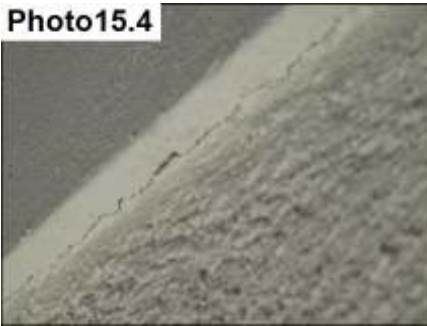
Photo15.4

- The accent band/stucco termination sealants are deteriorating. The inspector suggests to have a qualified stucco waterproofing contractor seal this area with NP1 or low modulus sealant in an effort to prevent moisture intrusion. These types of sealants are of high quality and compatible with stucco and other termination points. Please refer to photos #15.2, #15.3 and #15.4 for more detail.

Accent Band/Stucco Termination Sealants/ Seal

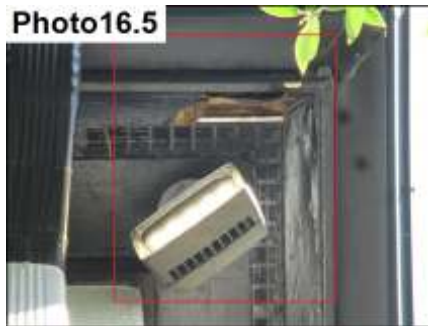
Photo16.5

- Wood rot noted on the soffit and fascia. Repair as needed. Please refer to photos #16.5 for more detail.
- The penetration sealants are separated or missing. The inspector suggests to have a qualified stucco waterproofing contractor seal this area with NP1 or low modulus sealant in an effort to prevent moisture intrusion. These types of sealants are of high quality and compatible with stucco and other termination points. Please refer to photos #16.6, #18.2, #18.3, #18.4, #18.5, #18.6 and #20.4 for more detail.

Wood Rot / Repair

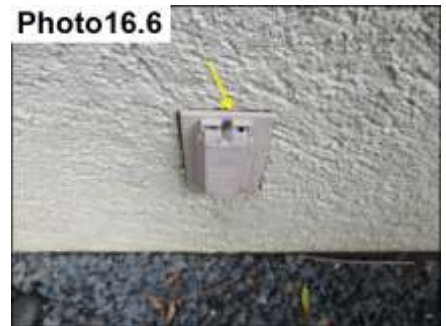
Photo16.6

Penetration Sealants/ Seal

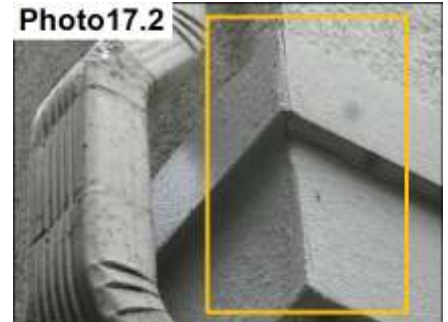
Photo17.2

- Cracks are noted in this location. The inspector suggests to have a qualified stucco waterproofing contractor repair these cracks in an effort to prevent moisture intrusion. Please refer to photos #17.2, #19.2, #19.3, #19.4, #19.5 and #19.6 for more detail.

Cracks/ Seal Or Repair

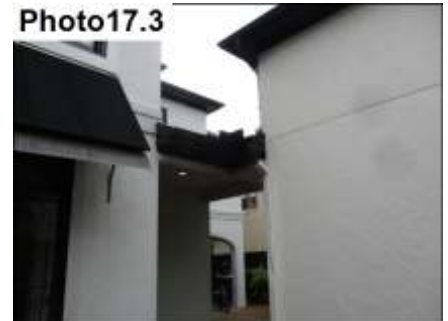
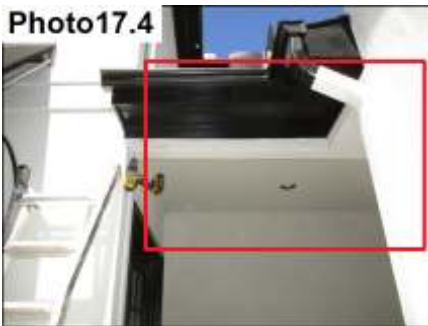
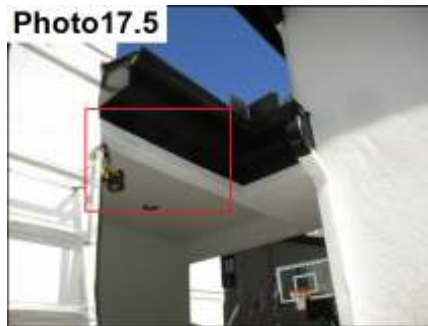
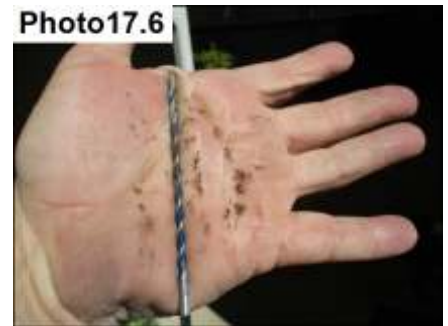
- Confirmed substrate damage is noted in the beam. The inspector suggests to have a qualified stucco waterproofing contractor repair this area in an effort to prevent moisture intrusion. Please refer to photos #17.3, #17.4, #17.5 and #17.6 for more detail.

Confirmed Substrate Damage/
Repair

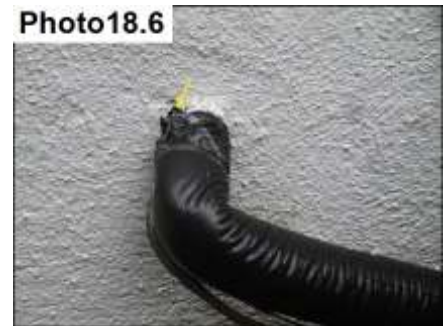
Photo18.6

Penetration Sealants/ Seal

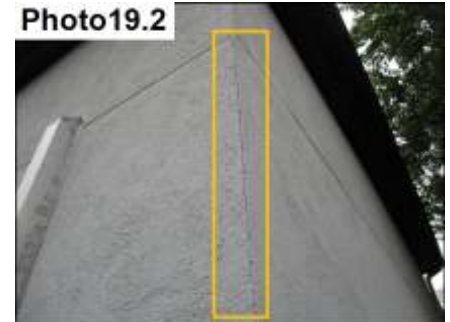
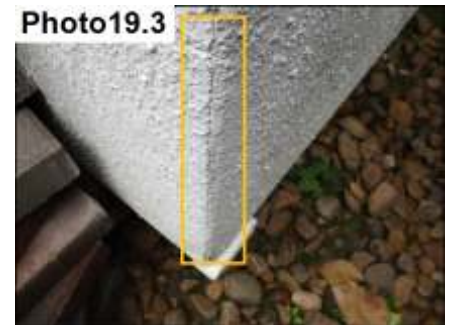
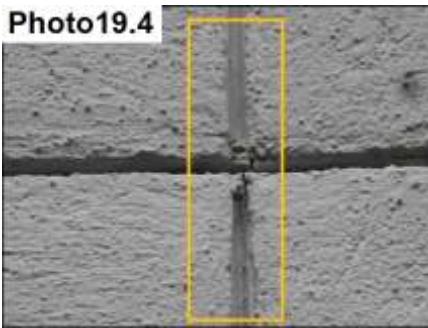
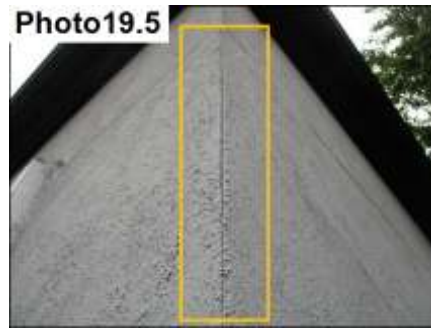
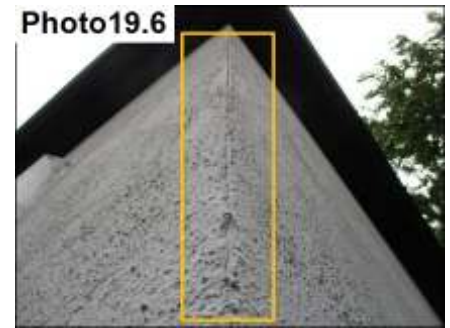
Cracks/ Repair

Grid Location	Item Description	Moisture Readings	Substrate Condition	Observations
Orange Boxes	Cracks			Cracks are noted in this location. The inspector suggests to have a qualified stucco waterproofing contractor repair these cracks in an effort to prevent moisture intrusion. Please refer to photos #19.2, #19.3, #19.4, #19.5 and #19.6 for more detail.
J7	Corner Wall	21%	Firm	A moisture probe was made at the corner wall. An elevated moisture reading was noted with a firm substrate.

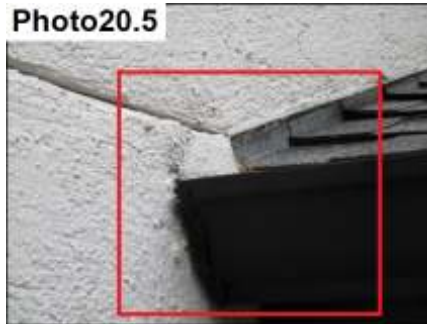
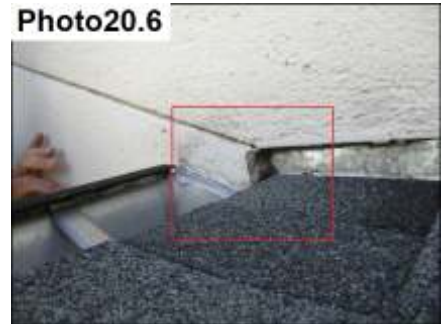
- The kickout flashing in this location is failing. The inspector suggests to have a qualified stucco waterproofing contractor to modify this area as needed in an effort to prevent moisture intrusion. Please refer to photos #20.5 and #20.6 for more detail.

Missing Kickout Flashing/ Modify

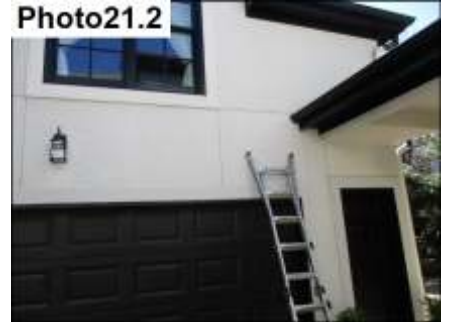
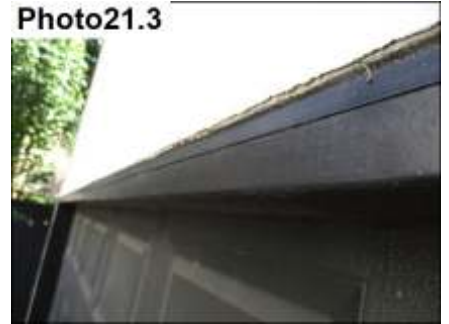
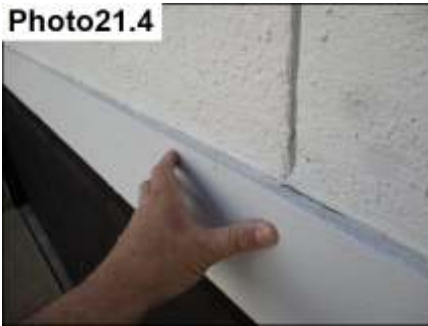
- Semi-soft and semi-firm substrate is noted in the garage header below the failing kickout and windows. The inspector suggests to have a qualified stucco waterproofing contractor further asses and repair this area in an effort to prevent moisture intrusion. Please refer to photos #21.2, #21.3, and #21.4 for more detail.

Confirmed Substrate Damage/
Repair

Grid Location	Item Description	Moisture Readings	Substrate Condition	Observations
Red Box	Confirmed Substrate Damage			Semi-soft and semi-firm substrate is noted in the garage header below the failing kickout and windows. The inspector suggests to have a qualified stucco waterproofing contractor further asses and repair this area in an effort to prevent moisture intrusion. Please refer to photos #21.2, #21.3 and #21.4 for more detail.
I5	Garage Header Right Below Missing Kickout	29%	Semi-Soft	A moisture probe was made at the garage header right below the missing kickout. The substrate was semi soft and the inspector suggests to modify as needed.
H5	Garage Header	26%	Semi-Soft	A moisture probe was made at the garage header right below the window. The substrate was semi soft and the inspector suggests to modify as needed.
G5	Garage Header	27%	Semi-Firm	A moisture probe was made at the garage header right below the window. The substrate was semi firm and the inspector suggests to modify as needed.

F5	Garage Header	26%	Semi-Firm	A moisture probe was made at the garage header right below the window. The substrate was semi firm and the inspector suggests to modify as needed.

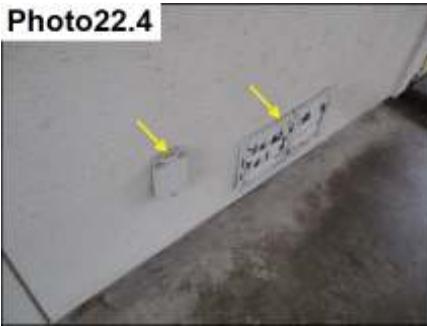
Photo22.4

Penetration Sealants/ Seal

Grid Location	Item Description	Moisture Readings	Substrate Condition	Observations
Yellow Arrow	Penetration Sealants			The penetration sealants are missing. The inspector suggests to have a qualified stucco waterproofing contractor seal this area with NP1 or low modulus sealant in an effort to prevent moisture intrusion. These types of sealants are of high quality and compatible with stucco and other termination points. Please refer to photos #22.2, #22.3 and #22.4 for more detail.

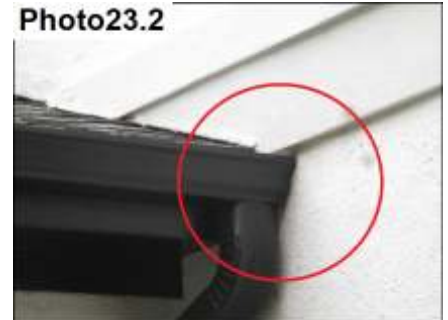
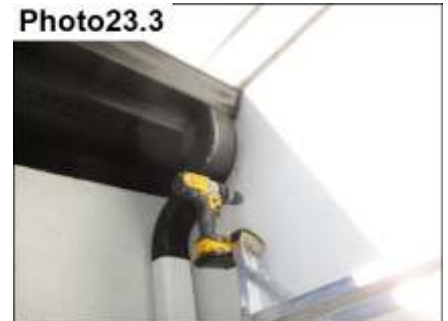
- The kickout flashing is missing from this location and substrate damage noted. The inspector suggests to have a qualified stucco waterproofing contractor to modify this area in an effort to prevent moisture intrusion. Please refer to photos #23.2 and #23.4 for more detail.

Missing Kickout Flashing/ Modify

Grid Location	Item Description	Moisture Readings	Substrate Condition	Observations
Red Circle	Missing Kickout			The kickout flashing is missing from this location and substrate damage noted. The inspector suggests to have a qualified stucco waterproofing contractor to modify this area in an effort to prevent moisture intrusion. Please refer to photos #23.2 and #23.4 for more detail.
Red Box	Confirmed Substrate Damage			Semi-firm substrate is noted in the bottom wall. The inspector suggests to have a qualified stucco waterproofing contractor to install a relief in an effort to allow proper moisture intrusion. Please refer to photos #23.4 and #23.5 for more detail.
C5	Below Missing Kickout		None	A moisture probe was made below the missing kickout. No substrate was noted at this time, suggested to modify as needed.
D4	Bottom Wall	20%	Firm	A moisture probe was made at the bottom wall. An elevated moisture reading was noted with a firm substrate.

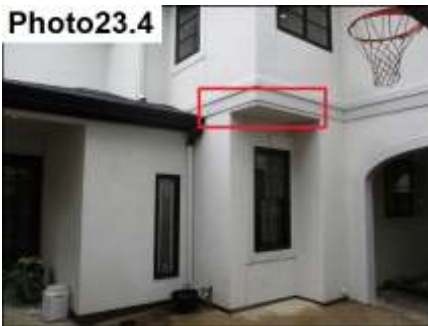
Photo23.4

- Semi-firm substrate is noted in the bottom wall. The inspector suggests to have a qualified stucco waterproofing contractor to install a relief in an effort to allow proper moisture intrusion. Please refer to photos #23.4 and #23.5 for more detail.

Confirmed Substrate Damage/
Repair And Install Relief

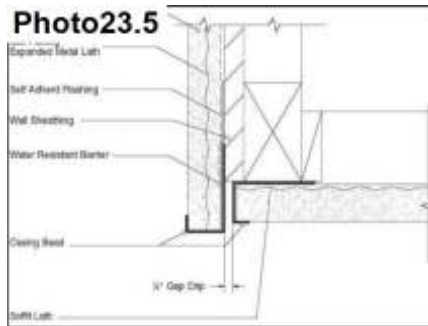
Photo23.5

Proper Relief Detail

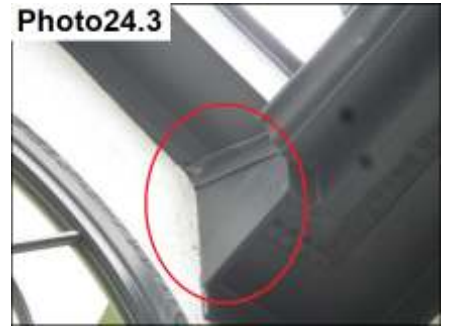
Photo24.3

- The roof diverter flashing sealants are separated or missing. The inspector suggests to have a qualified stucco waterproofing contractor seal this area with NP1 or low modulus sealant in an effort to prevent moisture intrusion. These types of sealants are of high quality and compatible with stucco and other termination points. Please refer to photos #7.4, #7.5, #24.2 and #24.3 for more detail.

Roof Diverter Flashing Sealants/
Seal

Grid Location	Item Description	Moisture Readings	Substrate Condition	Observations
Red Circles	Roof Diverter Flashing Sealants			The roof diverter flashing sealants are separated or missing. The inspector suggests to have a qualified stucco waterproofing contractor seal this area with NP1 or low modulus sealant in an effort to prevent moisture intrusion. These types of sealants are of high quality and compatible with stucco and other termination points. Please refer to photos #24.2 and #24.3 for more detail.
