Lone Star Stucco, LLC

Moisture Assessment Report

1234 Main St

Houston, TX 77007

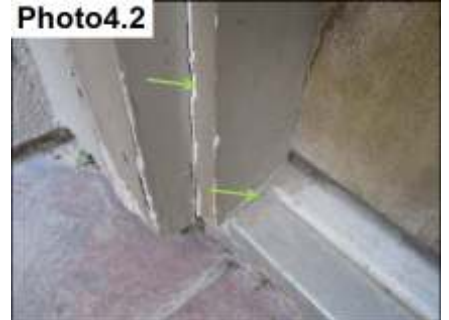
Photo4.2

- The door trim and miter sealants are separated or missing. The inspector suggests to have a qualified stucco waterproofing contractor seal this area with NP1 or low modulus sealant an effort to prevent moisture intrusion. These types of sealants are of high quality and compatible with stucco and other termination points. Please refer to photos #4.2, #4.3, #4.4, #4.5 and #4.6 for more detail.

Door Trim And Miter Sealants/ Seal

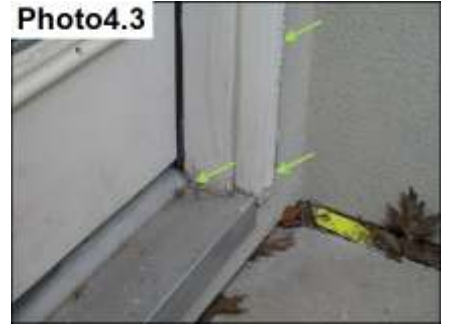
Photo4.3

Door Trim And Miter Sealants/ Seal

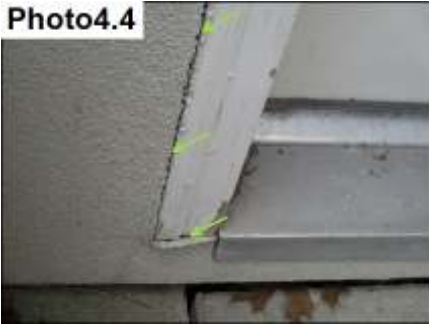
Photo4.4

Door Trim And Miter Sealants/ Seal

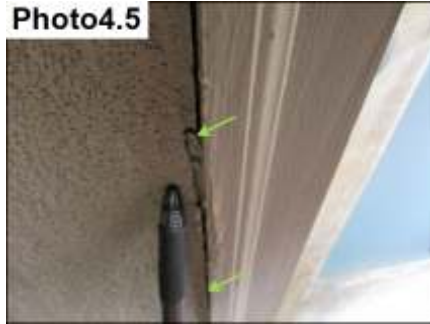
Photo4.5

Door Trim And Miter Sealants/ Seal

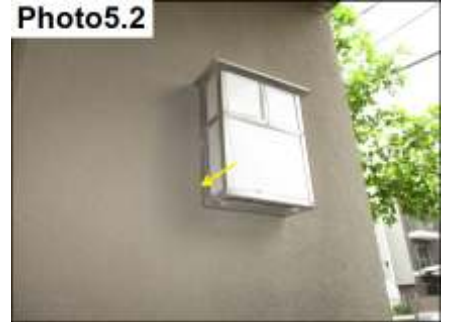
Photo5.2

- The penetration sealants are separated or missing. The inspector suggests to have a qualified stucco waterproofing contractor seal this area with NP1 or low modulus sealant an effort to prevent moisture intrusion. These types of sealants are of high quality and compatible with stucco and other termination points. Please refer to photos #5.2, #5.3, #5.4, #5.5 and #5.6 for more detail.

Penetration Sealants/ Seal

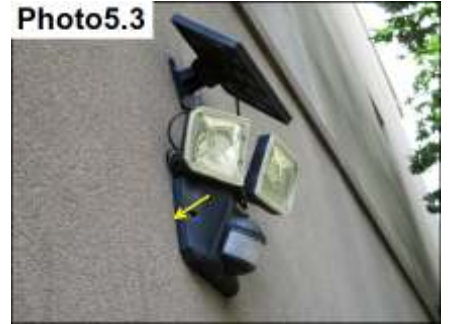
Photo5.3

Penetration Sealants/ Seal

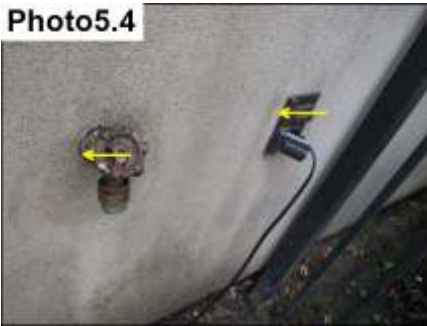
Photo5.4

Penetration Sealants/ Seal

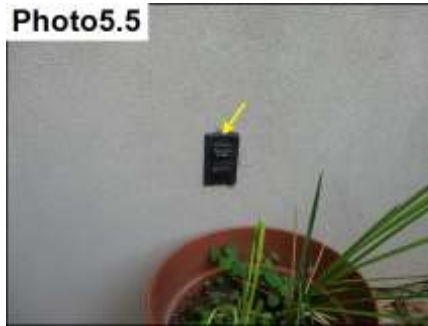
Photo5.5

Penetration Sealants/ Seal

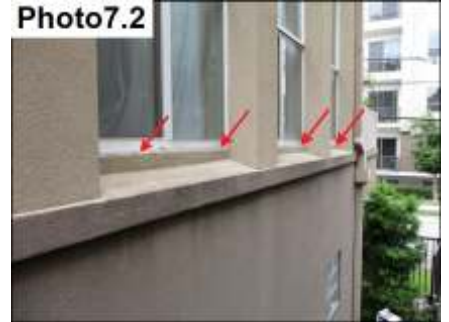
Photo7.2

- The window sealants are separated. The inspector suggests to have a qualified stucco waterproofing contractor seal this area with NP1 or low modulus sealant an effort to prevent moisture intrusion. These types of sealants are of high quality and compatible with stucco and other termination points. Please refer to photos #7.2, #7.3, #7.4, #7.5 and #7.6 for more detail.

Window Sealants/ Seal

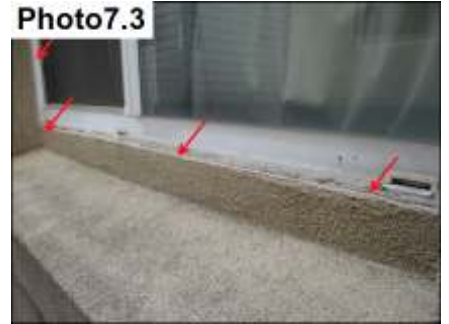
Photo7.3

Window Sealants/ Seal

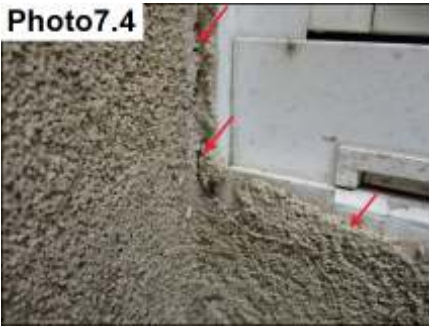
Photo7.4

Window Sealants/ Seal

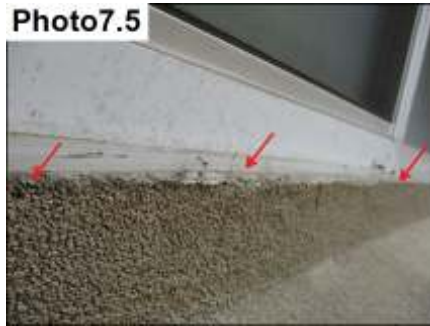
Photo7.5

Window Sealants/ Seal

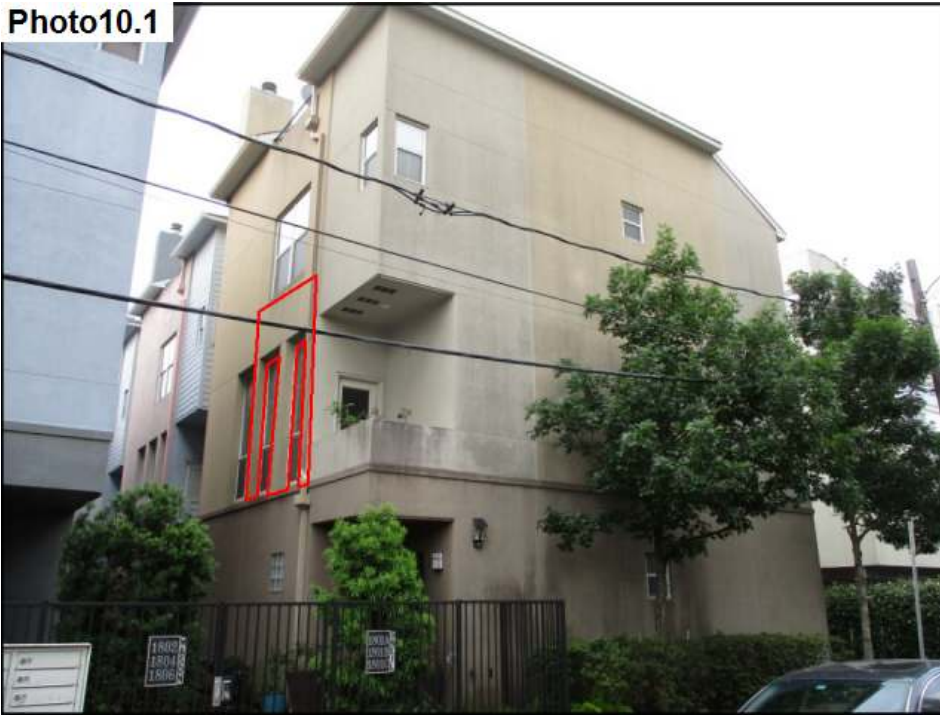
Photo10.1

- Potential damage is noted in the third floor window header below the failing rooftop pony wall with cracked flat accent. The inspector suggests to have a qualified stucco waterproofing contractor core sample assess then repair this area if needed. Note the inspector was unable to reach this location. Please refer to photos #10.1 for more detail.

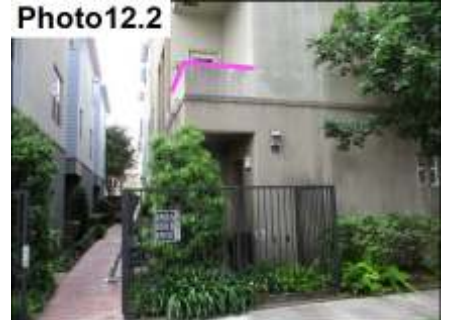
Photo12.2

- A flat accent has been noted at these areas. The inspector suggests to consult with a qualified stucco waterproofing contractor to add a metal cap to all flat accents in an effort to prevent moisture intrusion. Please refer to photos #12.2, #12.3 and #12.4 for more detail.

Flat Accent/ Add Metal Cap

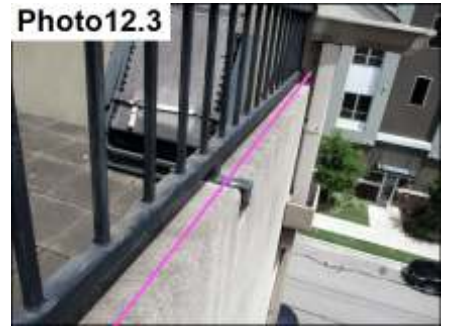
Photo12.3

Flat Accent/ Add Metal Cap

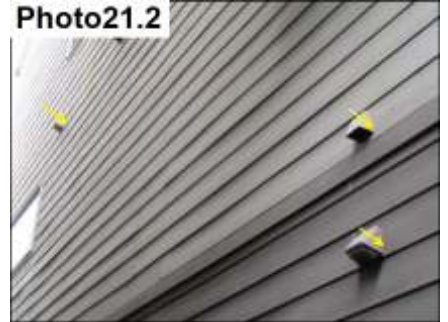
Photo21.2

Penetration Sealants/ Seal

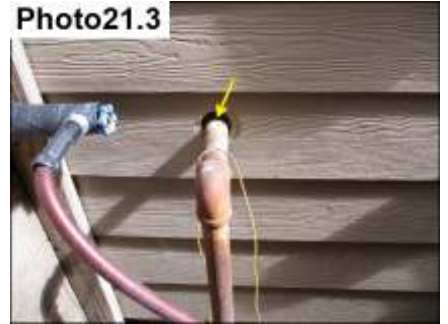
Photo21.3

Penetration Sealants/ Seal

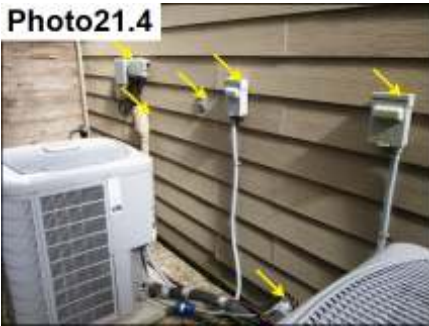
Photo21.4

Penetration Sealants/ Seal

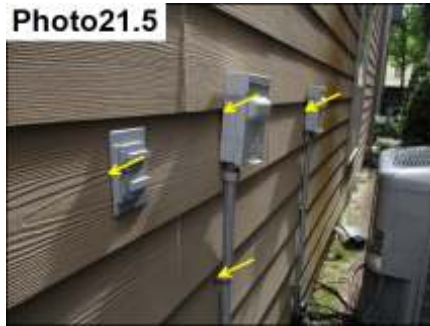
Photo21.5

Penetration Sealants/ Seal

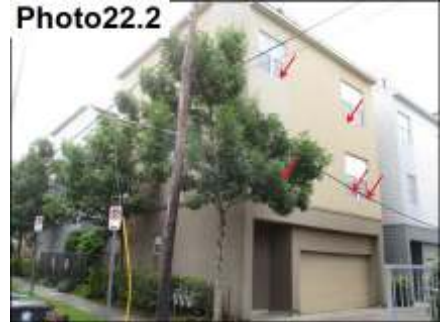
Photo22.2

Window Sealants/ Seal

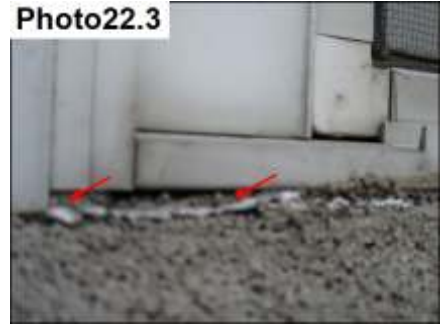
Photo22.3

Window Sealants/ Seal

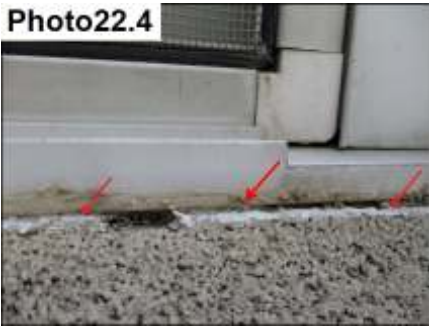
Photo22.4

Window Sealants/ Seal

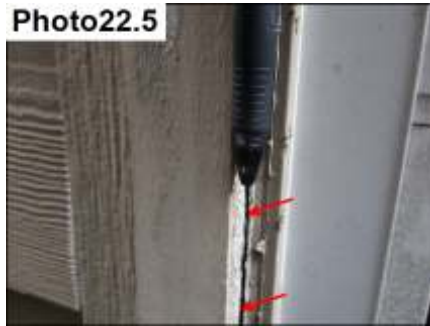
Photo22.5

Window Sealants/ Seal

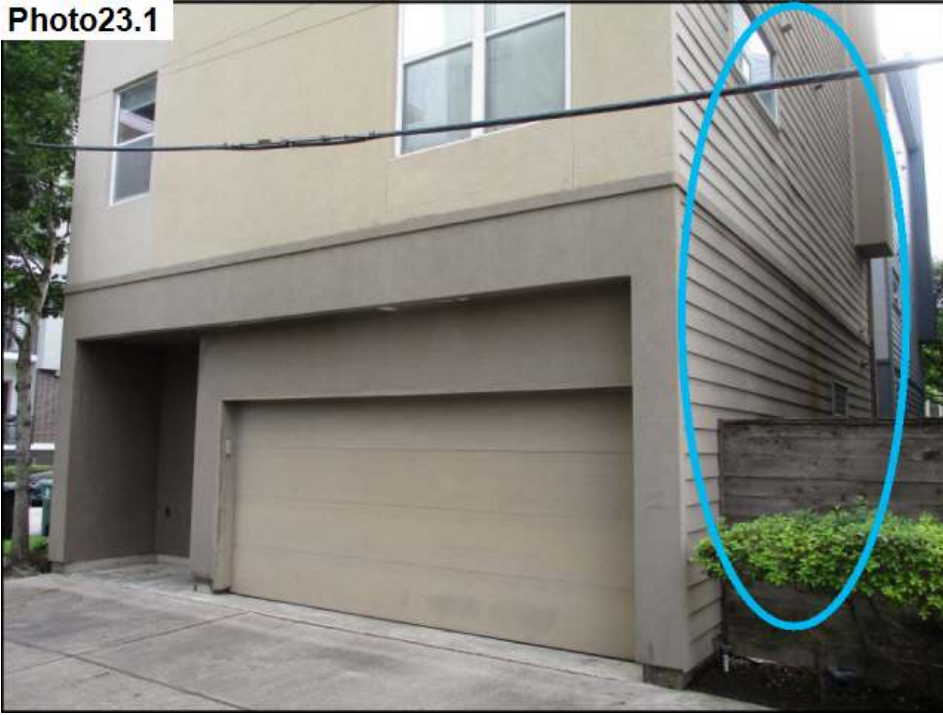
Photo23.1

Grid Location	Item Description	Moisture Readings	Substrate Condition	Observations
Blue Circle	Siding Sealants			The siding sealants are separated. The inspector suggests to have a qualified waterproofing contractor seal this area as needed in an effort to prevent moisture intrusion. Please refer to photos #23.2, #23.3, #23.4, #23.5 and #23.6 for more detail.

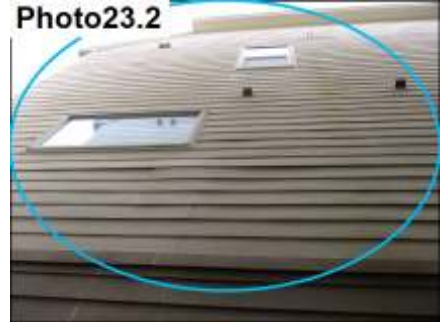
Photo23.2

- The siding sealants are separated. The inspector suggests to have a qualified waterproofing contractor seal this area as needed in an effort to prevent moisture intrusion. Please refer to photos #23.2, #23.3, #23.4, #23.5 and #23.6 for more detail.

Siding Sealants/ Seal

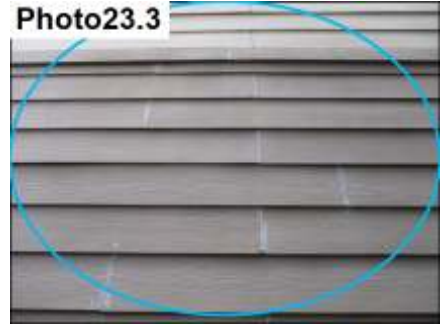
Photo23.3

Siding Sealants/ Seal

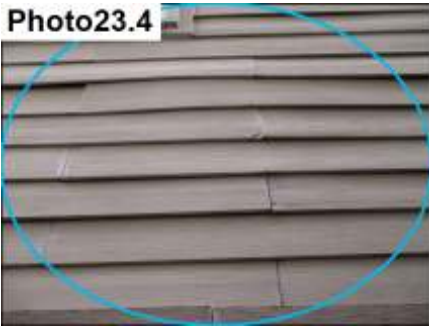
Photo23.4

Siding Sealants/ Seal

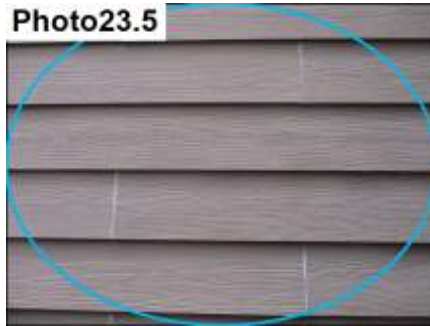
Photo23.5

Siding Sealants/ Seal

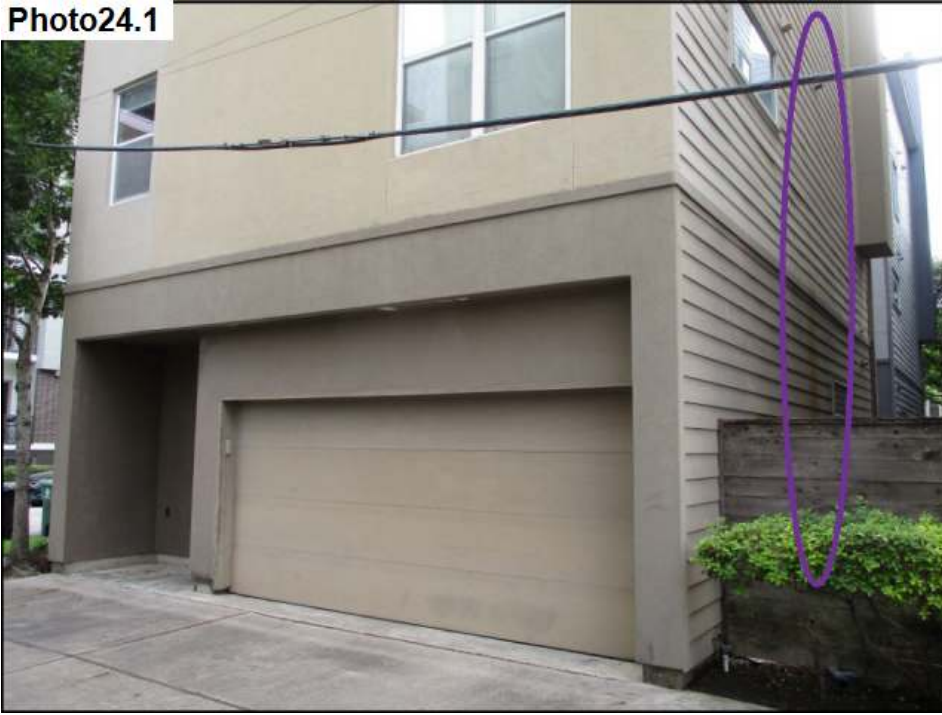
Photo24.1

Grid Location	Item Description	Moisture Readings	Substrate Condition	Observations
Purple Circle	Rust Stains			Rust stains from the over-flow are noted in this area. The inspector suggests to clean this location with a wire brush and paint as needed. Please refer to photos #24.2, #24.3 and #24.4 for more detail.

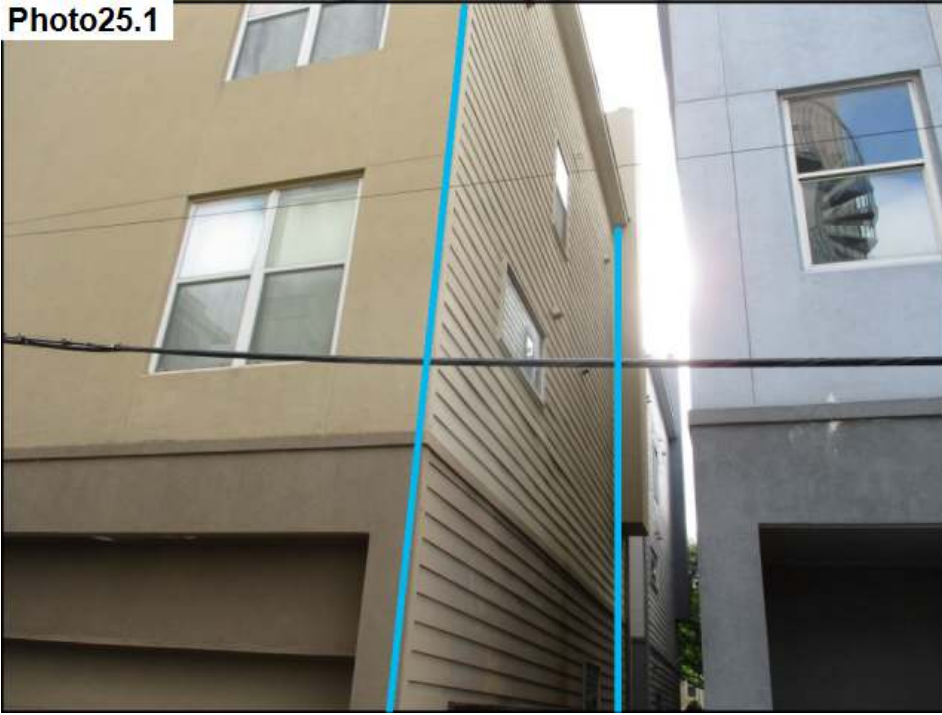
Photo25.1

Grid Location	Item Description	Moisture Readings	Substrate Condition	Observations
Blue Lines	Siding Trim/Stucco Termination Sealants			The siding trim/stucco termination sealants are separated. The inspector suggests to have a qualified stucco waterproofing contractor seal this area with NP1 or low modulus sealant an effort to prevent moisture intrusion. These types of sealants are of high quality and compatible with stucco and other termination points. Please refer to photos #25.2, #25.3, #25.4, #25.5 and #25.6 for more detail.

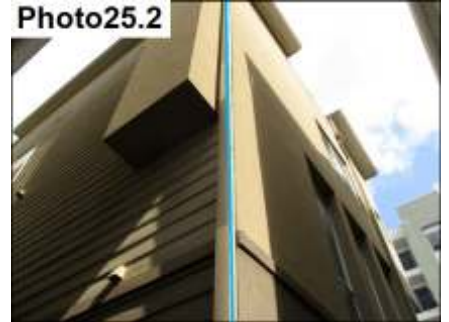
Photo25.2

- The siding trim/stucco termination sealants are separated. The inspector suggests to have a qualified stucco waterproofing contractor seal this area with NP1 or low modulus sealant an effort to prevent moisture intrusion. These types of sealants are of high quality and compatible with stucco and other termination points. Please refer to photos #25.2, #25.3, #25.4, #25.5 and #25.6 for more detail.

Siding Trim/Stucco Termination Sealants/ Seal

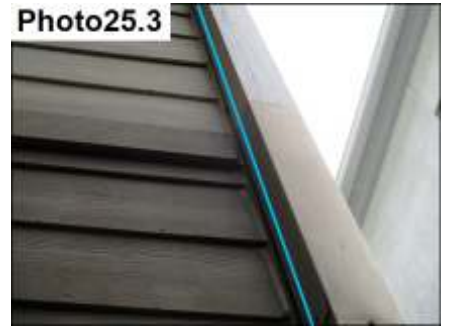
Photo25.3

Siding Trim/Stucco Termination Sealants/ Seal

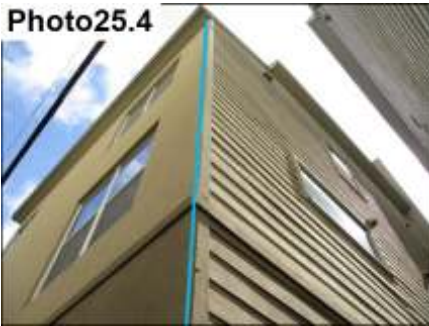
Photo25.4

Siding Trim/Stucco Termination Sealants/ Seal

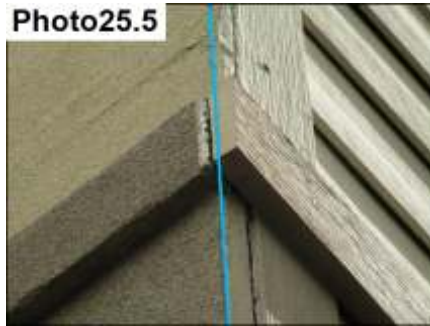
Photo25.5

Siding Trim/Stucco Termination Sealants/ Seal

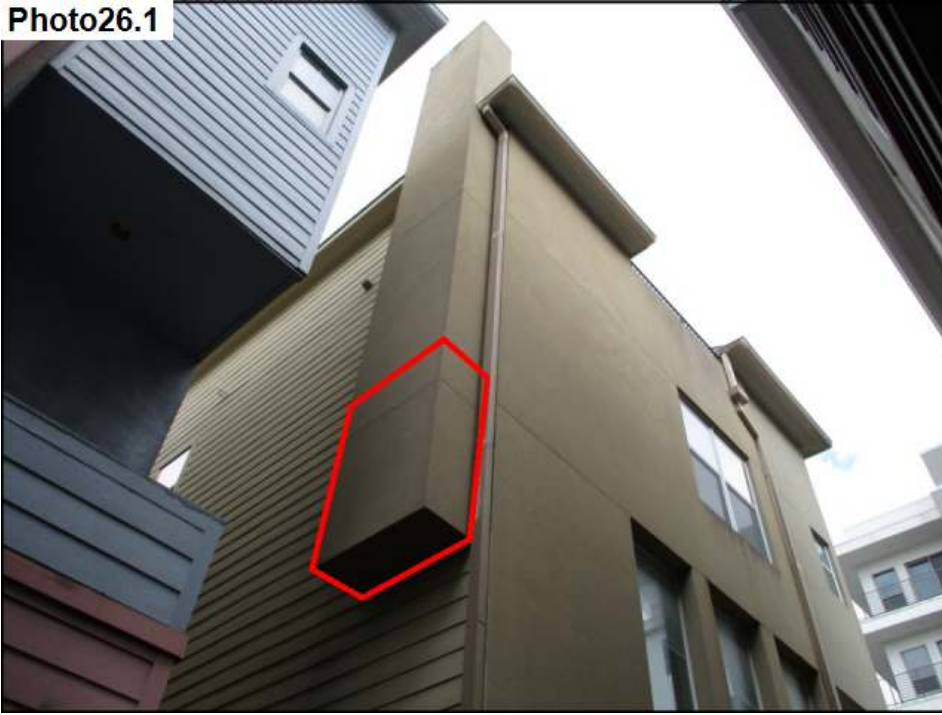
Photo26.1

- Potential substrate frame damage is noted in the chimney chase. The inspector suggests to have a qualified stucco waterproofing contractor further assess and repair this area as needed and to install a relief in an effort to allow proper moisture evacuation. Please refer to photos #26.1 for more detail.
