Lone Star Stucco, LLC

Moisture Assessment Report

12345 Sample St

2/24/2019

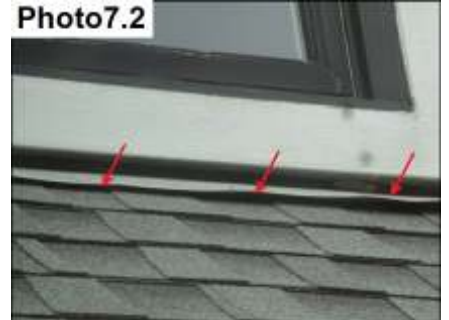
Photo7.2

Roof Penetration/ Re-Fasten And Seal

Grid Location	Item Description	Moisture Readings	Substrate Condition	Observations
Red Arrows	Roof Penetration			The roof penetration in this location is pulling away from the roof deck. The inspector suggests to re-fasten and seal this area as needed in an effort to prevent moisture intrusion. Please refer to photos #7.2 for more detail.
Yellow Arrow	Penetration Sealants			The penetration sealants are missing. The inspector suggests to have a qualified stucco waterproofing contractor seal this area with NP1 or low modulus sealant in an effort to prevent moisture intrusion. These types of sealants are of high quality and compatible with stucco and other termination points. Please refer to photo #7.3 for more detail.
Red Circles	Roof Diverter Flashing Sealants			The roof diverter flashing sealants are separated or missing. The inspector suggests to have a qualified stucco waterproofing contractor seal this area with NP1 or low modulus sealant in an effort to prevent moisture intrusion. These types of sealants are of high quality and compatible with stucco and other termination points. Please refer to photos #7.4 and #7.5 for more detail.

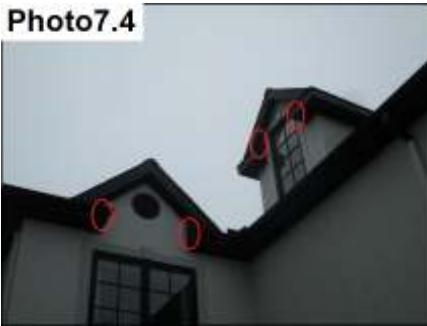
Photo7.4

Roof Diverter Flashing Sealants/ Seal

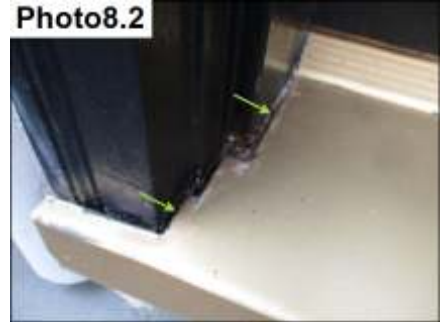
Photo8.2

Door Miter Sealants/ Seal

Grid Location	Item Description	Moisture Readings	Substrate Condition	Observations
Green Arrows	Door Miter Sealants			The door miter sealants are separated or missing. The inspector suggests to have a qualified stucco waterproofing contractor seal this area with NP1 or low modulus sealant in an effort to prevent moisture intrusion. These types of sealants are of high quality and compatible with stucco and other termination points. Please refer to photos #8.2, #8.3, #8.4 and #8.5 for more detail.
Red Box	Wood Rot			Wood rot is noted in the bottom right door trim. The inspector suggests to have a qualified waterproofing contractor repair in an effort to prevent moisture intrusion. Please refer to photo #8.6 for more detail.

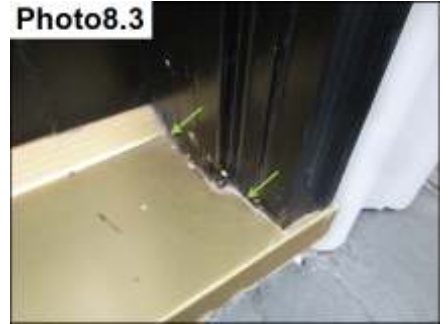
Photo8.3

Door Miter Sealants/ Seal

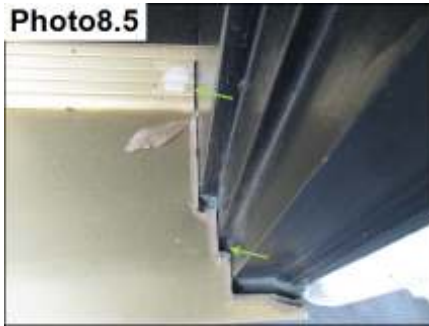
Photo8.5

Door Miter Sealants/ Seal

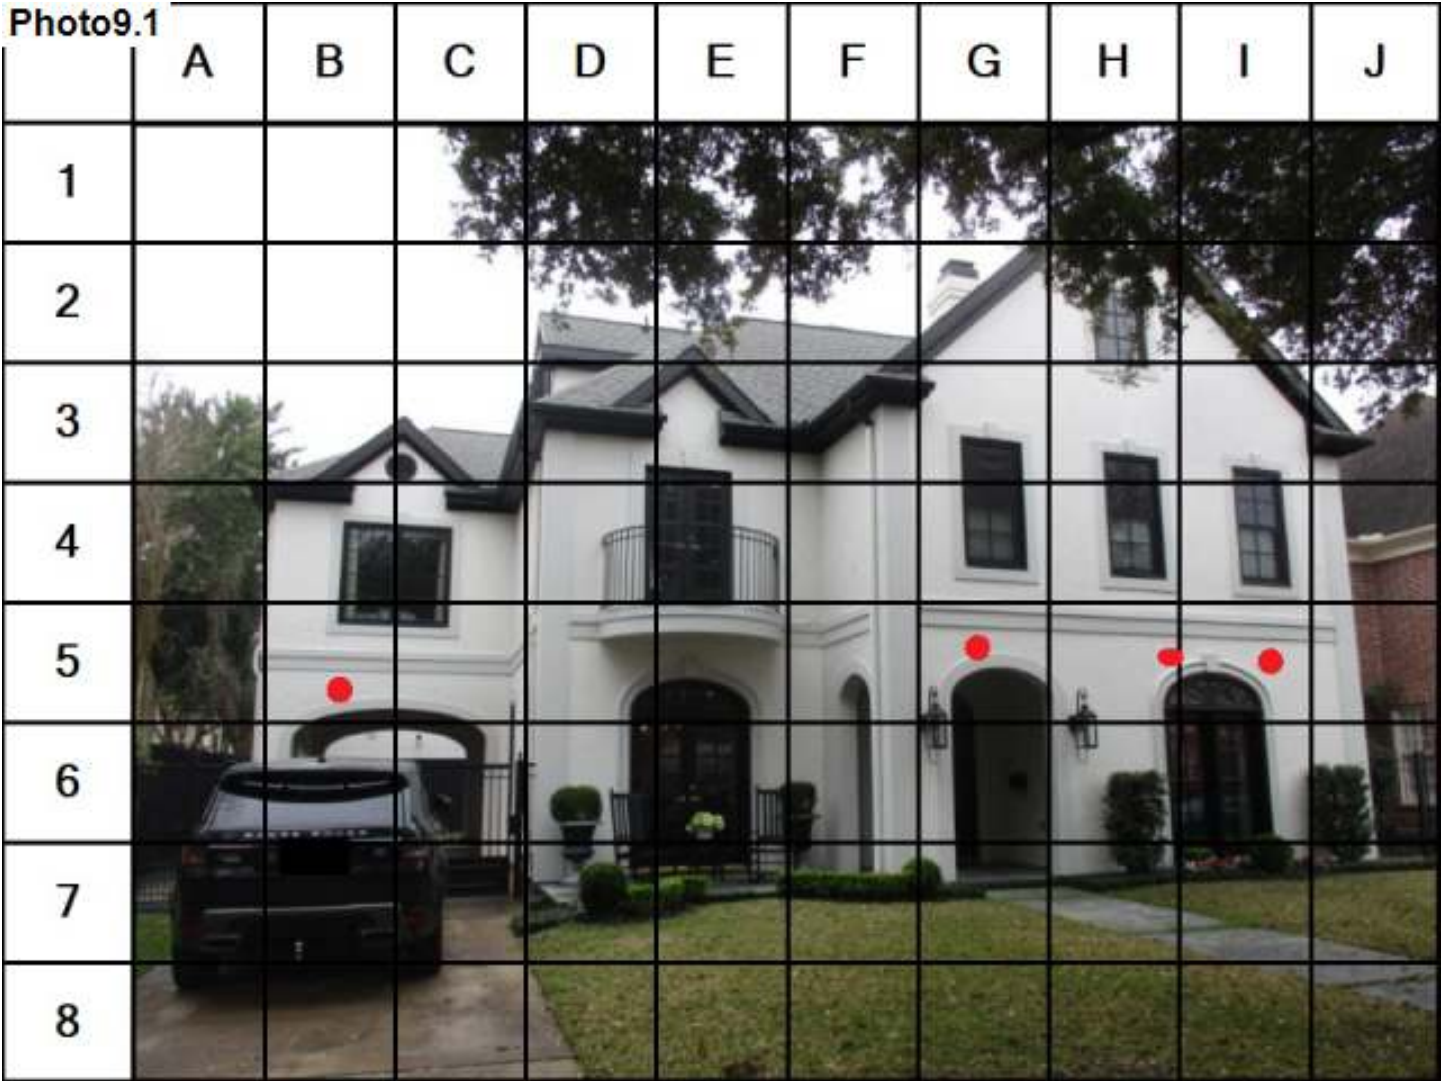
Photo9.1

Grid Location	Item Description	Moisture Readings	Substrate Condition	Observations
B5	Second Floor Window Bottom Left At Arch		None	A moisture probe was made at the second floor window bottom left at arch. No substrate was noted at this time, suggested to modify as needed.
G5	Second Floor Window Bottom Left At Arch	20%	Firm	A moisture probe was made at the second floor window bottom left at arch. An elevated moisture reading was noted with a firm substrate.
H5	Second Floor Window Bottom Left At Arch	22%	Firm	A moisture probe was made at the second floor window bottom left at arch. An elevated moisture reading was noted with a firm substrate.
I5	Second Floor Window Bottom Left At Arch	25%	Firm	A moisture probe was made at the second floor window bottom left at arch. An elevated moisture reading was noted with a firm substrate.

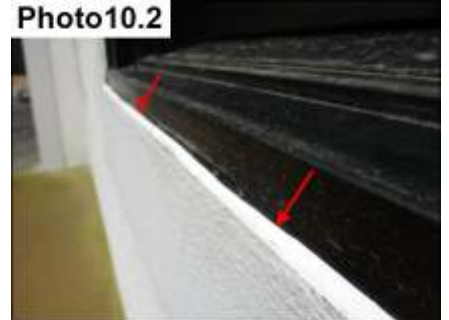
Photo10.2

Window Sealants/ Seal

Grid Location	Item Description	Moisture Readings	Substrate Condition	Observations
Red Arrow	Window Sealants			The window sealants are separated. The inspector suggests to have a qualified stucco waterproofing contractor seal this area with NP1 or low modulus sealant in an effort to prevent moisture intrusion. These types of sealants are of high quality and compatible with stucco and other termination points. Please refer to photos #10.2, and #10.3 for more detail.
Red Box	Bottom Of Arch			The bottom of arch below the windows has substrate damage. The inspector suggests to have a qualified stucco waterproofing contractor to repair this area and install a relief in an effort to prevent moisture intrusion. Please refer to photos #10.4, and #10.5 for more detail.
Orange Line	Accent/Stucco Termination Sealants			The accent/stucco termination sealants are separated. The inspector suggests to have a qualified stucco waterproofing contractor seal this area with NP1 or low modulus sealant in an effort to prevent moisture intrusion. These types of sealants are of high quality and compatible with stucco and other termination points. Please refer to photo #10.6 for more detail.

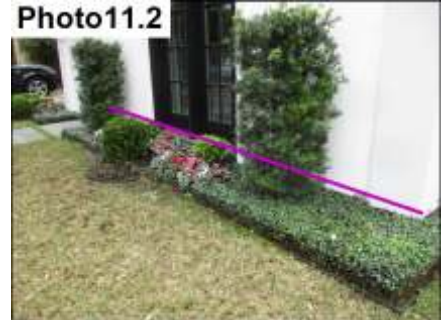
Photo11.2

Stucco In Close Proximity To Grade/
Pull Back

Grid Location	Item Description	Moisture Readings	Substrate Condition	Observations
Purple Line	Stucco In Close Proximity To Grade			The stucco is in close contact with the grade at this location. The inspector suggest to pull back all soil, rocks and plants away from the stucco in an effort to prevent moisture intrusion. Please refer to photo #11.2 for more detail.
Orange Box	Minor Substrate Damage			The improper direction of the sprinkler in this area as caused minor substrate damage to the bottom right of the door threshold. The inspector suggests to have a qualified waterproofing contractor repair this area in an effort to prevent moisture intrusion. Please refer to photos #11.3, #11.4 and #11.5 for more detail.

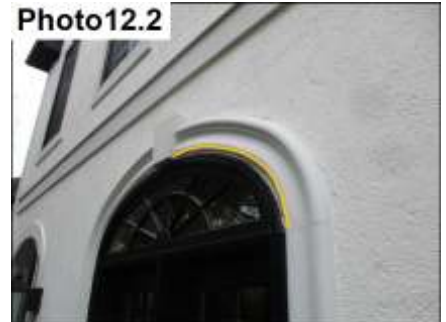
Photo12.2

Window/Accent Sealants/ Seal

Grid Location	Item Description	Moisture Readings	Substrate Condition	Observations
Orange Line	Window/Accent Sealants			The window/accent sealants are missing or deteriorating. The inspector suggests to have a qualified stucco waterproofing contractor seal this area with NP1 or low modulus sealant in an effort to prevent moisture intrusion. These types of sealants are of high quality and compatible with stucco and other termination points. Please refer to photos #12.2, #12.3 and #12.4 for more detail.
C5	Roof Diverter Flashing	17%	Firm	A moisture probe was made at the roof diverter flashing. The substrate is firm with no damage noted at this time.
G5	Roof Diverter Flashing	18%	Firm	A moisture probe was made at the roof diverter flashing. The substrate is firm with no damage noted at this time.

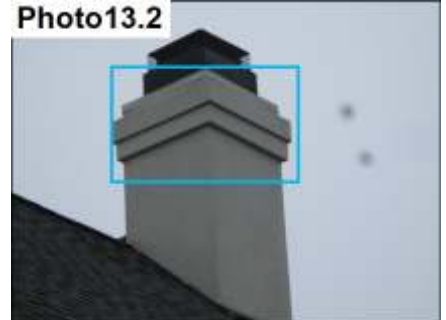
Photo13.2

Chimney Cap Present/ Seal Metal Cap/Accent Termination

Grid Location	Item Description	Moisture Readings	Substrate Condition	Observations
Blue Box	Chimney Cap			A chimney cap is present but the inspector suggests sealants on the metal cap/accent termination in an effort to prevent moisture intrusion. Please refer to photos #13.2, #13.3 and #13.4 for more detail.
Black Circle	Minor Crack			The minor crack in this location has been previously sealed. The inspector states that this is a positive detail. Please refer to photo #13.5 for more detail.

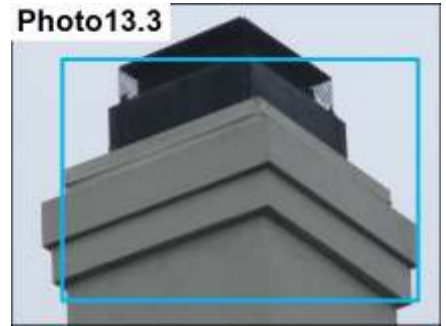
Photo13.3

Chimney Cap Present/ Seal Metal Cap/Accent Termination

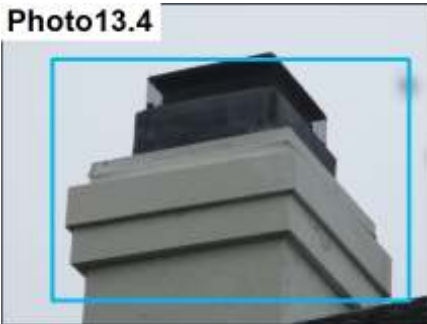
Photo13.4

Chimney Cap Present/ Seal Metal Cap/Accent Termination

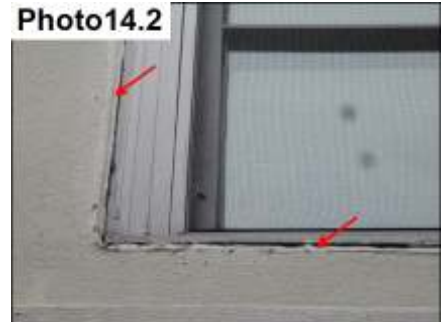
Photo14.2

Window Sealants/ Seal

Grid Location	Item Description	Moisture Readings	Substrate Condition	Observations
Red Arrows	Window Sealants			The window sealants are separated. The inspector suggests to have a qualified stucco waterproofing contractor seal this area with NP1 or low modulus sealant in an effort to prevent moisture intrusion. These types of sealants are of high quality and compatible with stucco and other termination points. Please refer to photos #14.2, #14.3, #14.4 and #14.5 for more detail.
G7	Window Bottom Left	20%	Firm	A moisture probe was made at the window bottom right. An elevated moisture reading was noted with a firm substrate.
H7	Window Bottom Left	21%	Firm	A moisture probe was made at the window bottom left. An elevated moisture reading was noted with a firm substrate.
G5	Window Header Left	18%	Firm	A moisture probe was made at the window header left. The substrate was firm with no damage noted at this time.

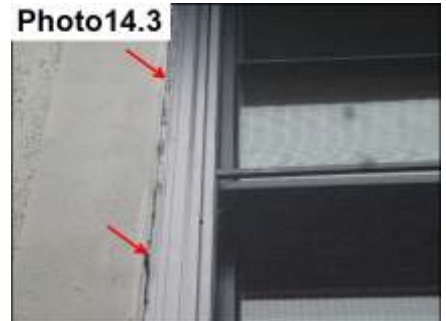
Photo14.3

Window Sealants/ Seal

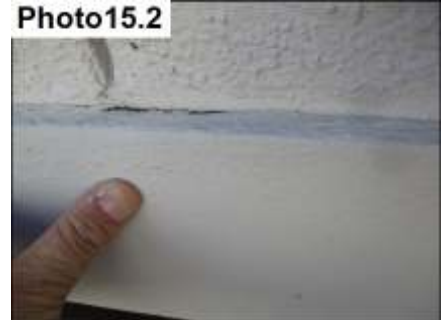
Photo15.2

Accent Band/Stucco Termination Sealants/ Seal

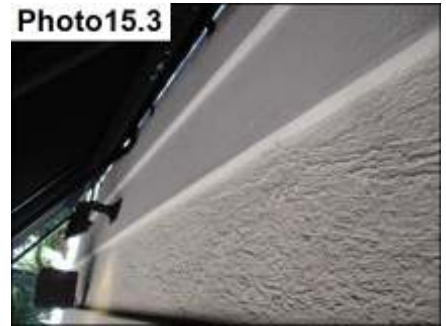
Photo15.3

Accent Band/Stucco Termination Sealants/ Seal

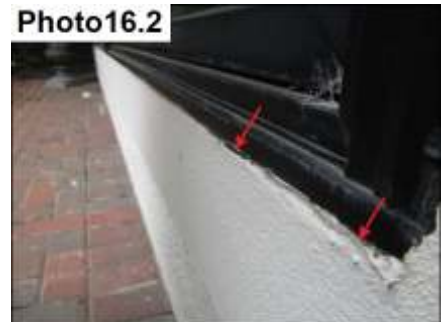
Photo16.2

Window Sealants/ Seal

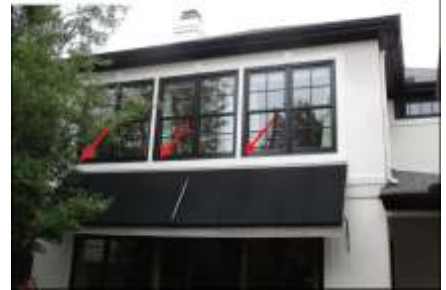
Photo16.3

Window Sealants/ Seal

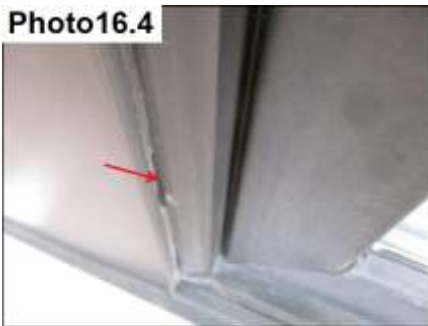
Photo16.4

Window Sealants/ Seal

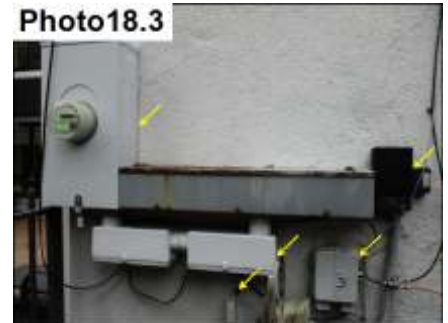
Photo18.3

Penetration Sealants/ Seal

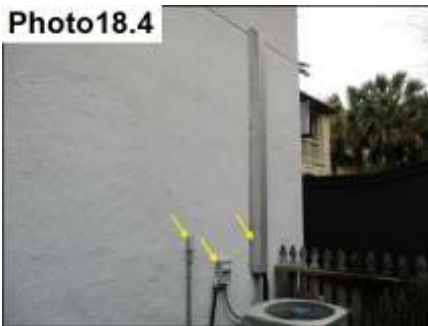
Photo18.4

Penetration Sealants/ Seal

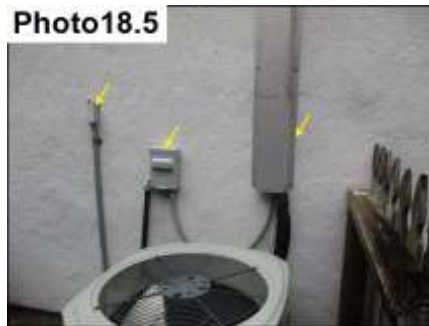
Photo18.5

Penetration Sealants/ Seal

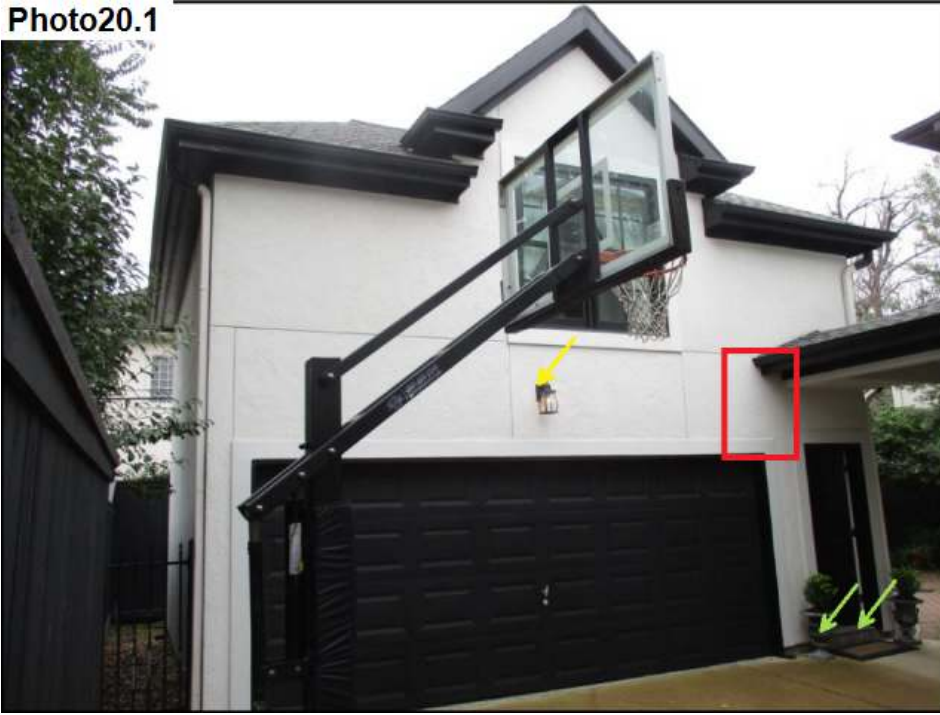
Photo20.1

Grid Location	Item Description	Moisture Readings	Substrate Condition	Observations
Green Arrows	Door Miter Sealants			The door miter sealants are separated or missing. The inspector suggests to have a qualified stucco waterproofing contractor seal this area with NP1 or low modulus sealant in an effort to prevent moisture intrusion. These types of sealants are of high quality and compatible with stucco and other termination points. Please refer to photos #20.2 and #20.3 for more detail.
Yellow Arrow	Penetration Sealants			The penetration sealants are separated or missing. The inspector suggests to have a qualified stucco waterproofing contractor seal this area with NP1 or low modulus sealant in an effort to prevent moisture intrusion. These types of sealants are of high quality and compatible with stucco and other termination points. Please refer to photo #20.4 for more detail.
Red Box	Failing Kickout Flashing			The kickout flashing in this location is failing. The inspector suggests to have a qualified stucco waterproofing contractor to modify this area as needed in an effort to prevent moisture intrusion. Please refer to photos #20.5 and #20.6 for more detail.

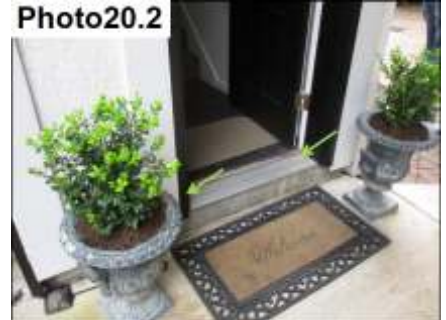
Photo20.2

Door Miter Sealants/ Seal

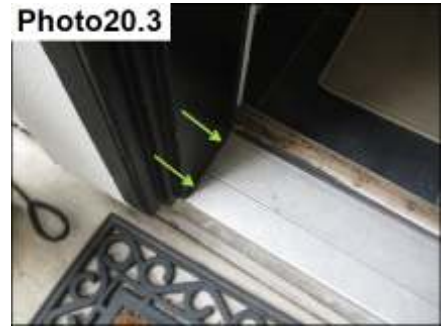
Photo20.3

Door Miter Sealants/ Seal

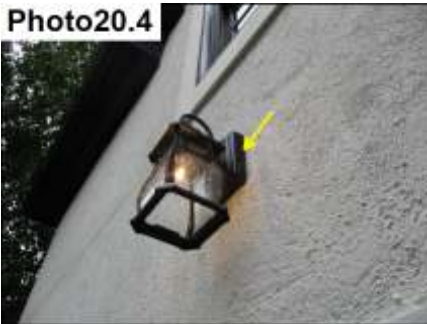
Photo20.4

Penetration Sealants/ Seal

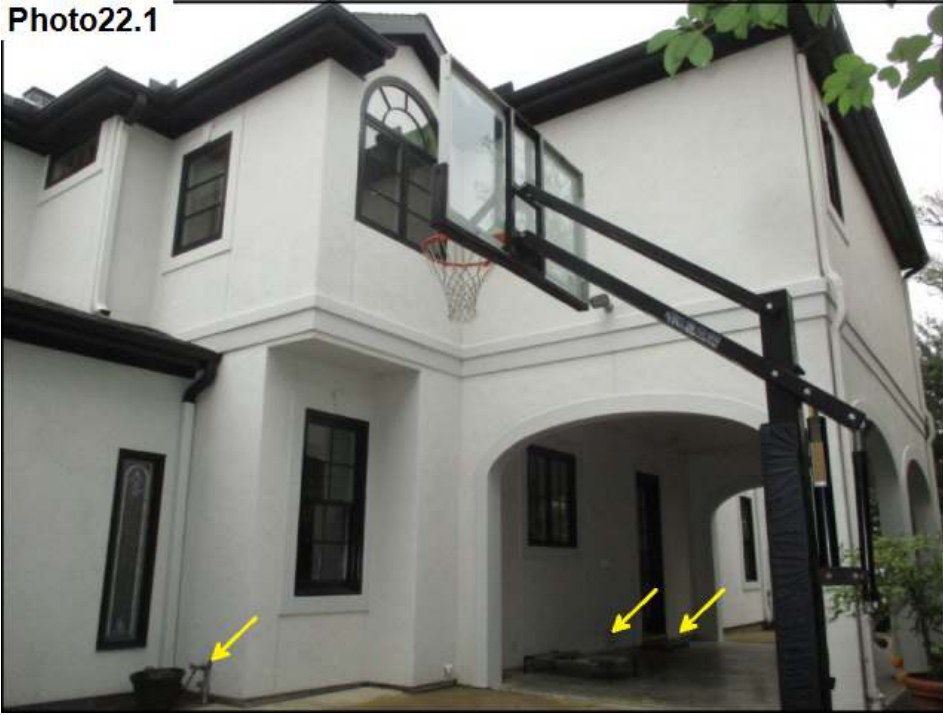
Photo22.1

Grid Location	Item Description	Moisture Readings	Substrate Condition	Observations
Yellow Arrow	Penetration Sealants			The penetration sealants are missing. The inspector suggests to have a qualified stucco waterproofing contractor seal this area with NP1 or low modulus sealant in an effort to prevent moisture intrusion. These types of sealants are of high quality and compatible with stucco and other termination points. Please refer to photos #22.2, #22.3 and #22.4 for more detail.

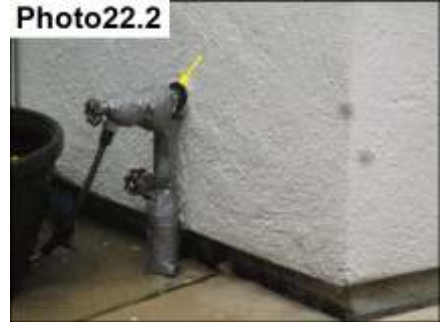
Photo22.2

Penetration Sealants/ Seal

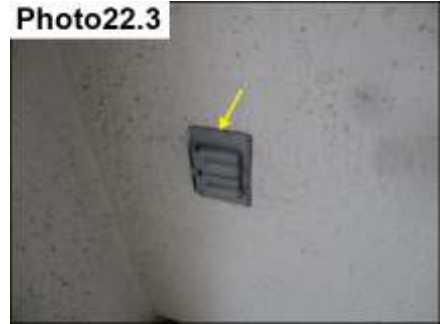
Photo22.3

Penetration Sealants/ Seal

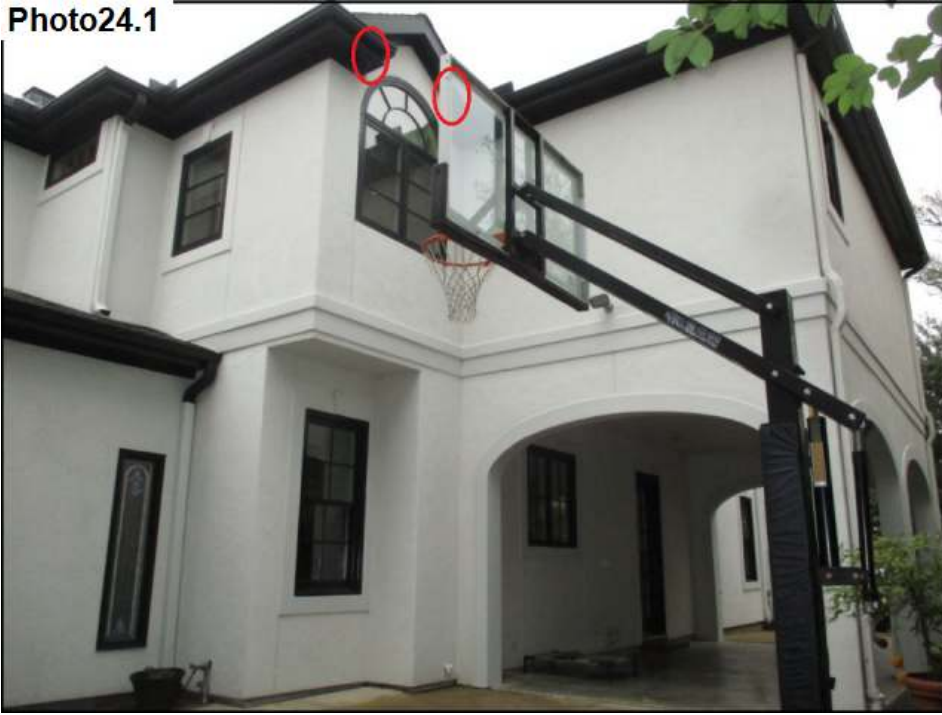
Photo24.1

Grid Location	Item Description	Moisture Readings	Substrate Condition	Observations
Red Circles	Roof Diverter Flashing Sealants			The roof diverter flashing sealants are separated or missing. The inspector suggests to have a qualified stucco waterproofing contractor seal this area with NP1 or low modulus sealant in an effort to prevent moisture intrusion. These types of sealants are of high quality and compatible with stucco and other termination points. Please refer to photos #24.2 and #24.3 for more detail.

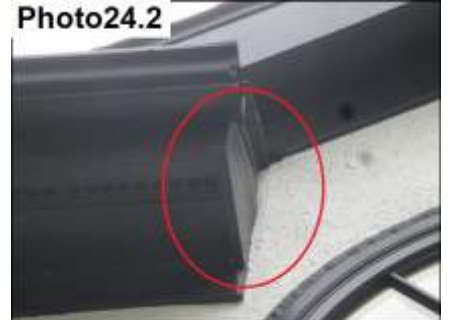
Photo24.2

Roof Diverter Flashing Sealants/
Seal
